# RV Inspection Report

**Inspection Date:** 1/19/2022

2012 Keystone Cougar 330RBK

**Suite Wheels RV Inspections and Services, LLC.**

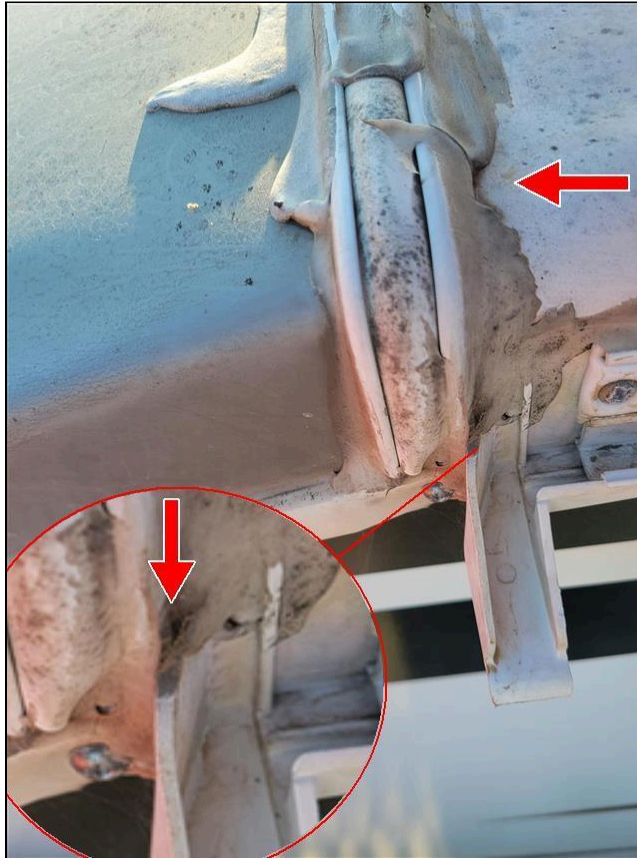
front cap - streetside gutter

(2) The Inspector noted three potential water intrusion points on the streetside front cap near the gutter downspout. Two directly at the downspout and the third is approximately 3.5 inches from the streetside edge. It is recommended this be repaired by a qualified RV Technician.
- \$

**2.1** (2) The Inspector noted three potential water intrusion points on the streetside front cap near the gutter downspout. Two directly at the downspout and the third is approximately 3.5 inches from the streetside edge. It is recommended this be repaired by a qualified RV Technician.

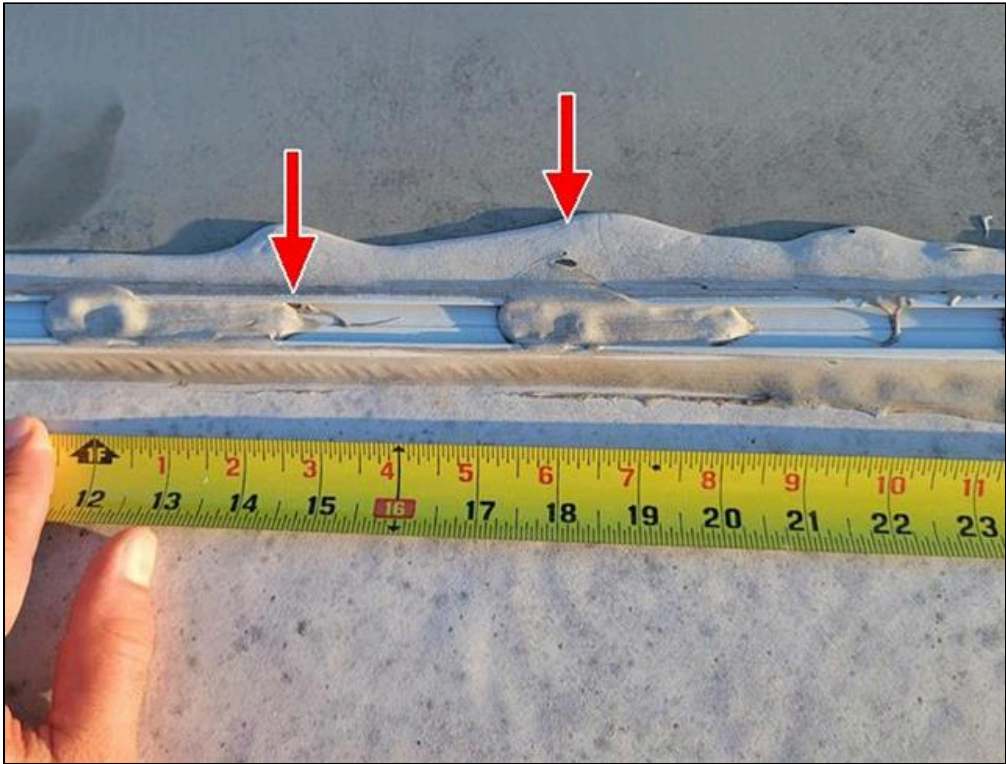
Front cap - main seam

(3) The inspector noted potential water intrusion points along the front cap main seam from the streetside at 14. inches in the center and at 18 inches on the front edge, An approximately 3 inch crack in the sealant was noted from the streetside edge stretching from 26.5 inches to 29.5 inches.It is recommended this be repaired by a qualified RV Technician.
- \$

**2.1** (3) The inspector noted potential water intrusion points along the front cap main seam from the streetside at 14. inches in the center and at 18 inches on the front edge, An approximately 3 inch crack in the sealant was noted from the streetside edge stretching from 26.5 inches to 29.5 inches. It is recommended this be repaired by a qualified RV Technician.

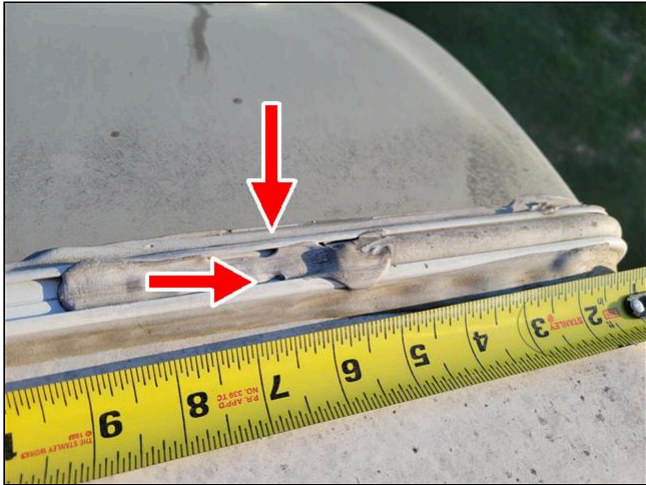
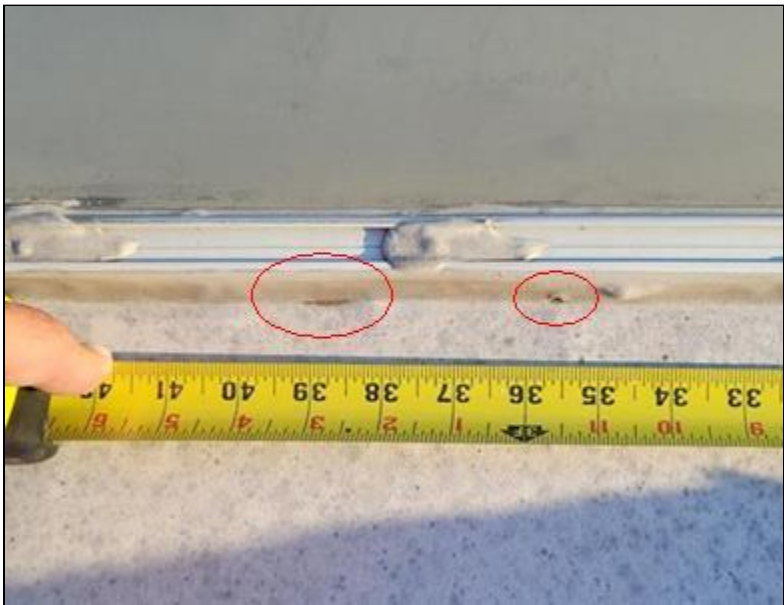
front cap - main seam

(4) The inspector noted two potential water intrusion points on the front cap seam rail at 7 inches from the curbside, one at 19 inches from the curbside, one at 35 inches from the curbside, and one at 39 inches from the curbside..It is recommended this be repaired by a qualified RV Technician.

2.1 (4) The inspector noted two potential water intrusion points on the front cap seam rail at 7 inches from the curbside, one at 19 inches from the curbside, one at 35 inches from the curbside, and one at 39 inches from the curbside..It is recommended this be repaired by a qualified RV Technician.

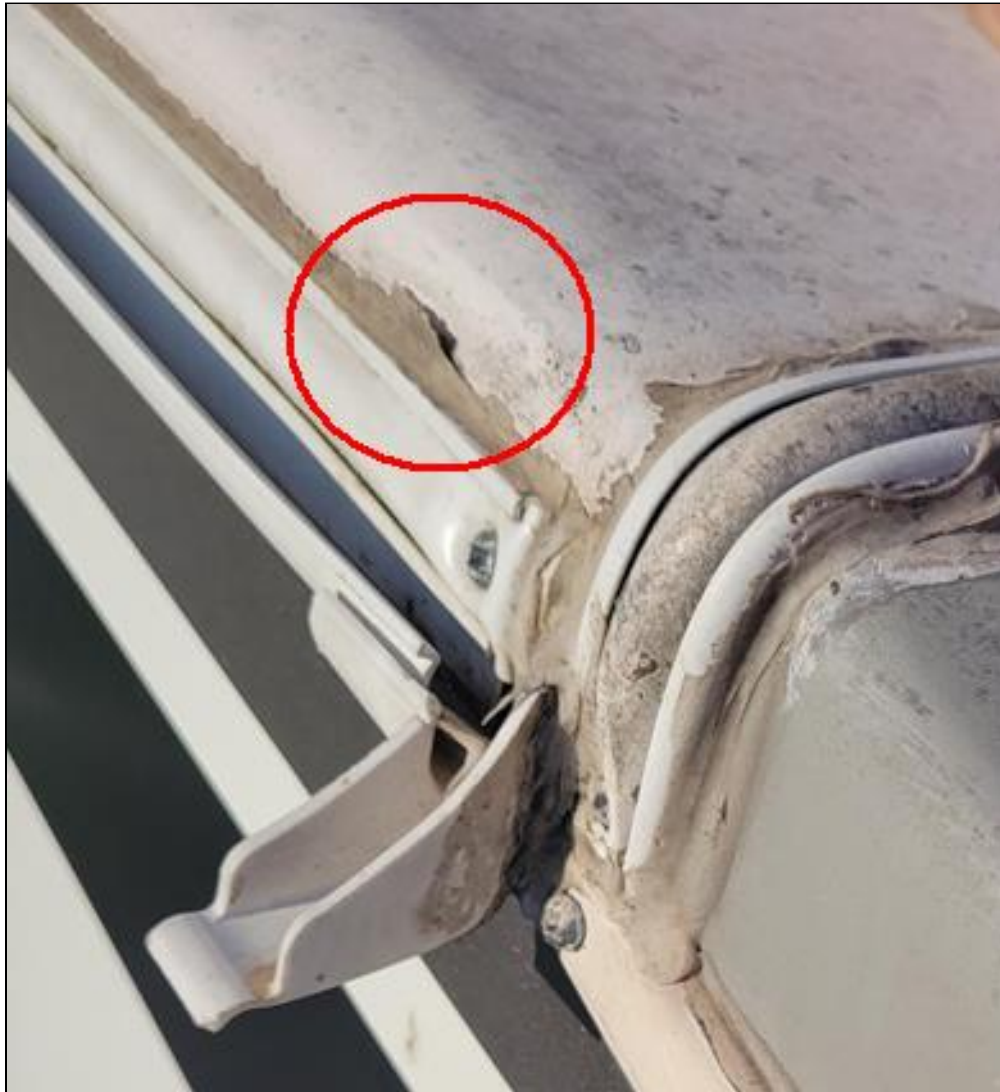
curbside trim rail - front gutter

(1) The Inspector noted a potential water intrusion point on the curbside trim rail approximately two inches to the rear of the front gutter downspout. It is also noted there is a crack in the sealant in the curbside trim rail above the rear gutter downspout at the rear cap. It is recommended this be repaired by a qualified RV Technician.

**2.2** (1) The Inspector noted a potential water intrusion point on the curbside trim rail approximately two inches to the rear of the front gutter downspout. It is also noted there is a crack in the sealant in the curbside trim rail above the rear gutter downspout at the rear cap. It is recommended this be repaired by a qualified RV Technician.

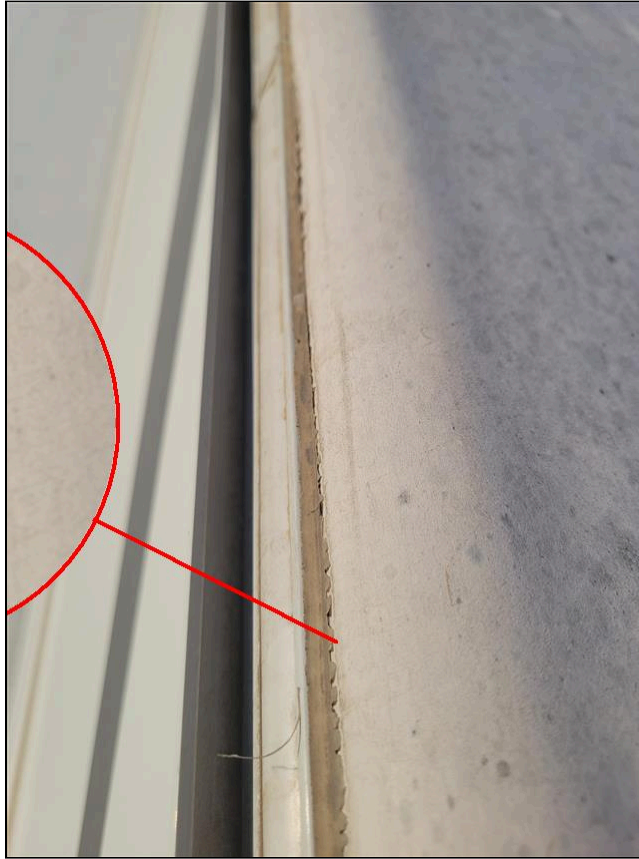
Curbside trim rail - sealant

(2) The inspector noted the deterioration of sealant along the entire length of the curbside trim rail from the front cap to the rear cap. It is recommended this be repaired by a qualified RV Technician.

**2.2** (2) The inspector noted the deterioration of sealant along the entire length of the curbside trim rail from the front cap to the rear cap. It is recommended this be repaired by a qualified RV Technician.

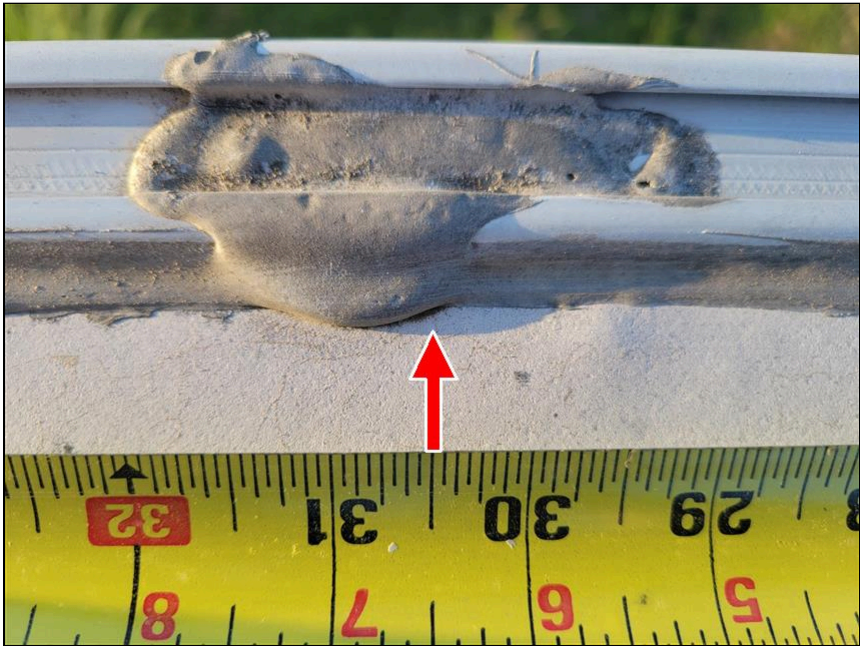
rear cap joint seal

(2) The inspector noted a three potential water intrusion points on the rear cap at the streetside rear cap corner as well as on the rear cap at 18.5 inches and 30.5 inches from the streetside edge. It is recommended this be repaired by a qualified RV Technician.

2.3 (2) The inspector noted a three potential water intrusion points on the rear cap at the streetside rear cap corner as well as on the rear cap at 18.5 inches and 30.5 inches from the streetside edge. It is recommended this be repaired by a qualified RV Technician.

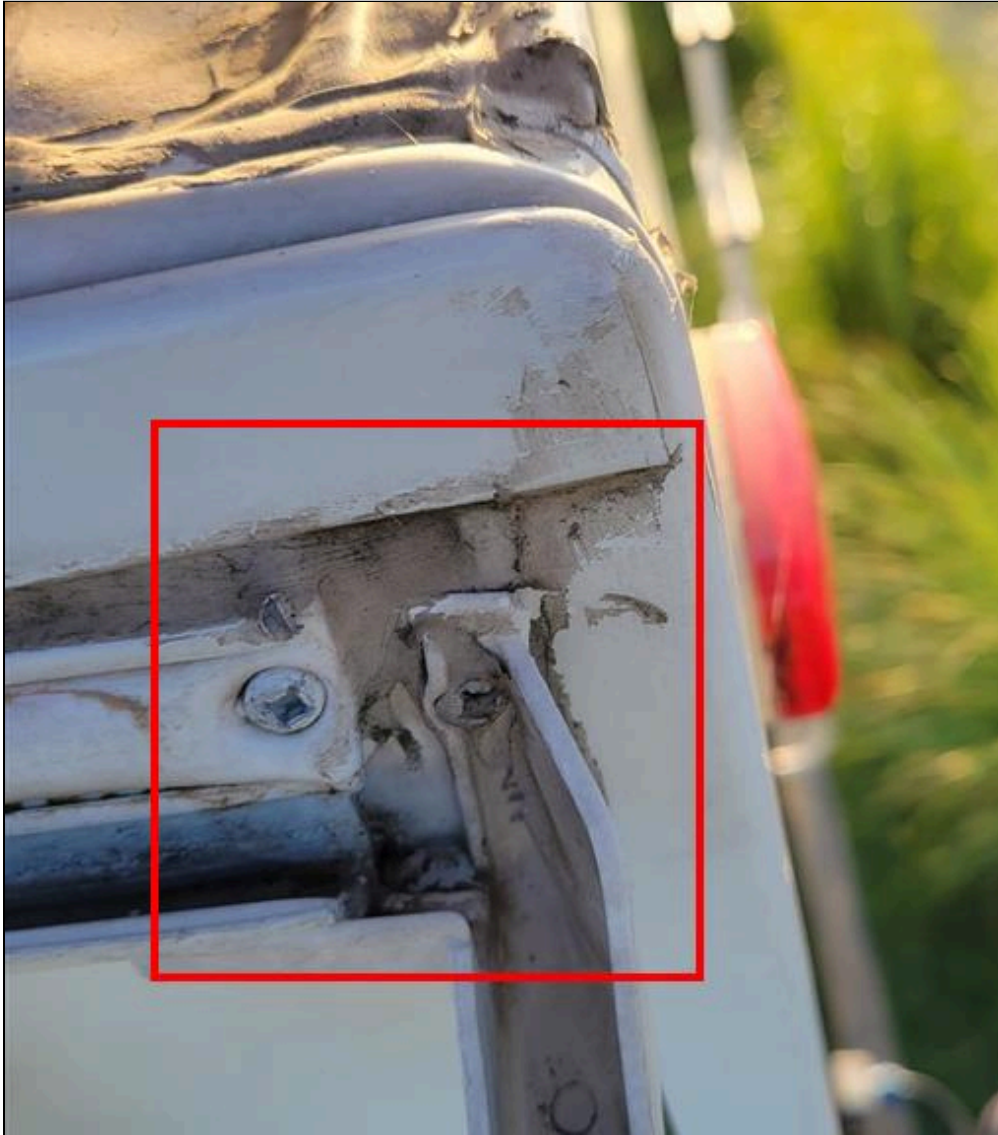
Curbside trim rail - rear downspout

(1) The inspector noted multiple potential water intrusion points on the streetside trim rail where the rail meets the rear cap gutter downspout. It is recommended this be repaired by a qualified RV Technician.

**2.4 (1)** The inspector noted multiple potential water intrusion points on the streetside trim rail where the rail meets the rear cap gutter downspout. It is recommended this be repaired by a qualified RV Technician.

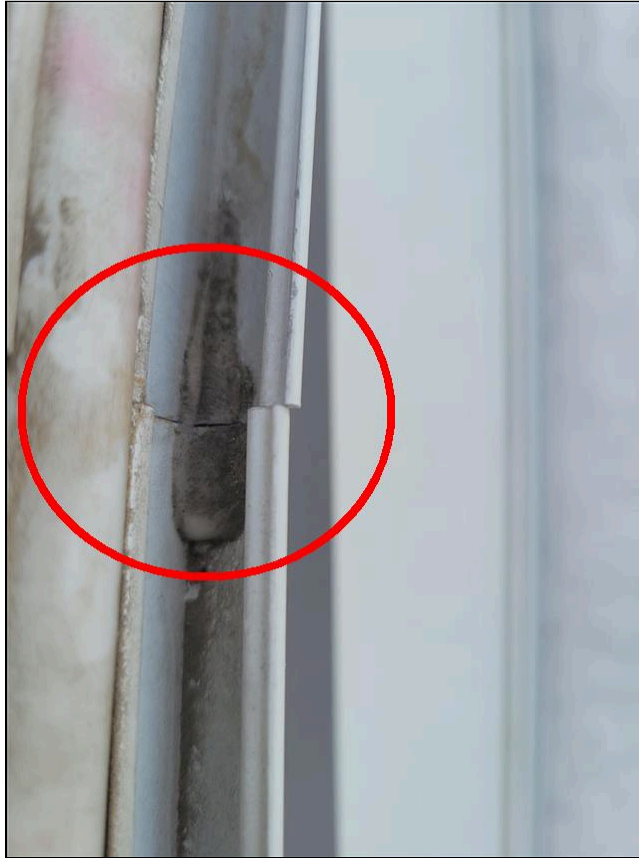
(2) The inspector noted that the missing and deterioration of the sealant in side the streetside gutter above the main slideout. It is recommended this be repaired by a qualified RV Technician.

**2.4 (2)** The inspector noted that the missing and deterioration of the sealant in side the streetside gutter above the main slideout. It is recommended this be repaired by a qualified RV Technician.

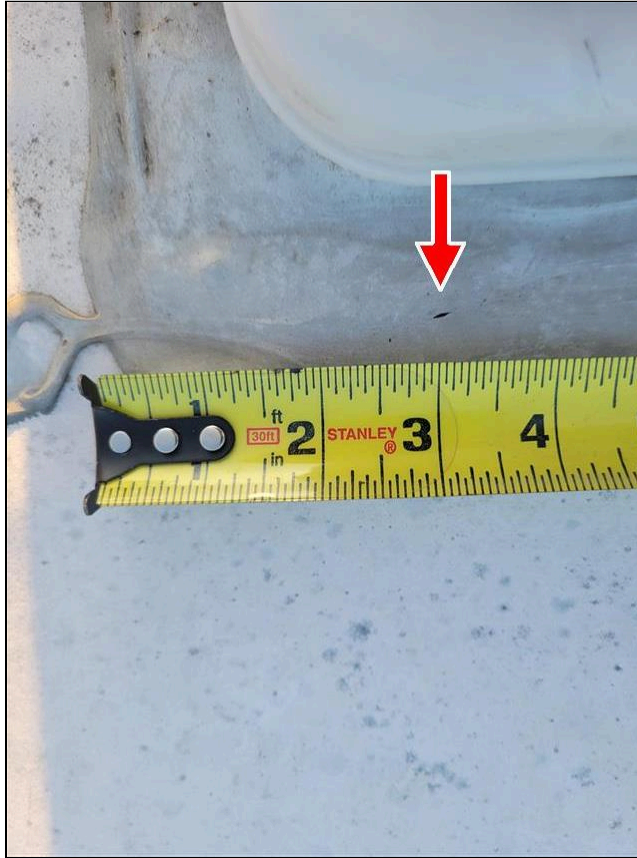
roof vent - third from front

(1) The inspector noted a potential water intrusion point in the sealant at the rear streetside corner edge of the third from the front roof vent. It is recommended this be repaired by a qualified RV Technician.

2.5 (1) The inspector noted a potential water intrusion point in the sealant at the rear streetside corner edge of the third from the front roof vent. It is recommended this be repaired by a qualified RV Technician.

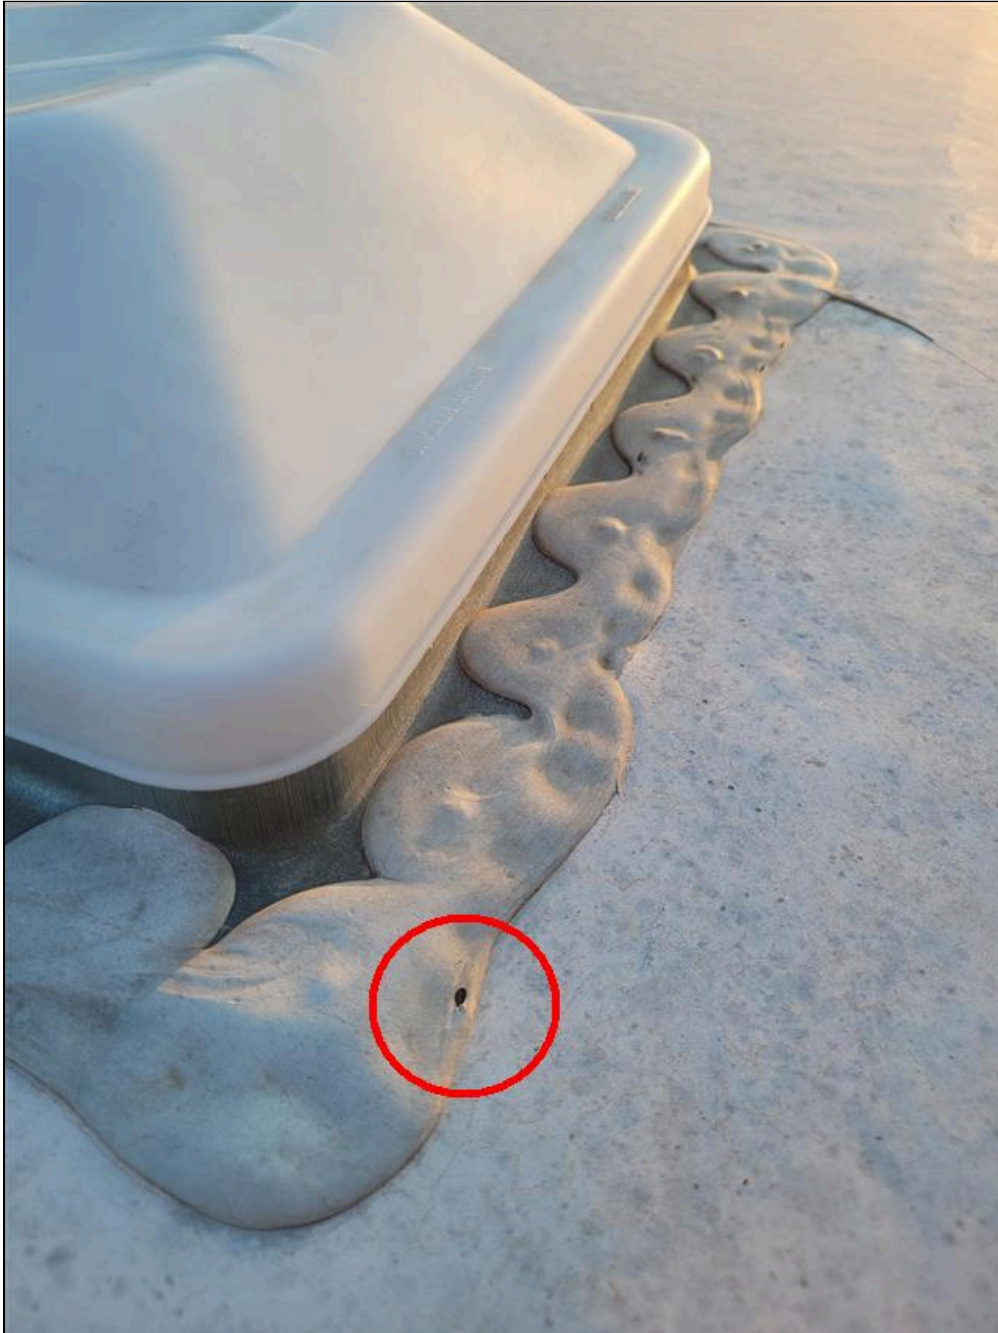
Roof vent - second from front

(2) The inspector noted a potential water intrusion point in the sealant on the rear streetside corner of the roof vent second from the front. It is recommended this be repaired by a qualified RV Technician.

**2.5 (2)** The inspector noted a potential water intrusion point in the sealant on the rear streetside corner of the roof vent second from the front. It is recommended this be repaired by a qualified RV Technician.

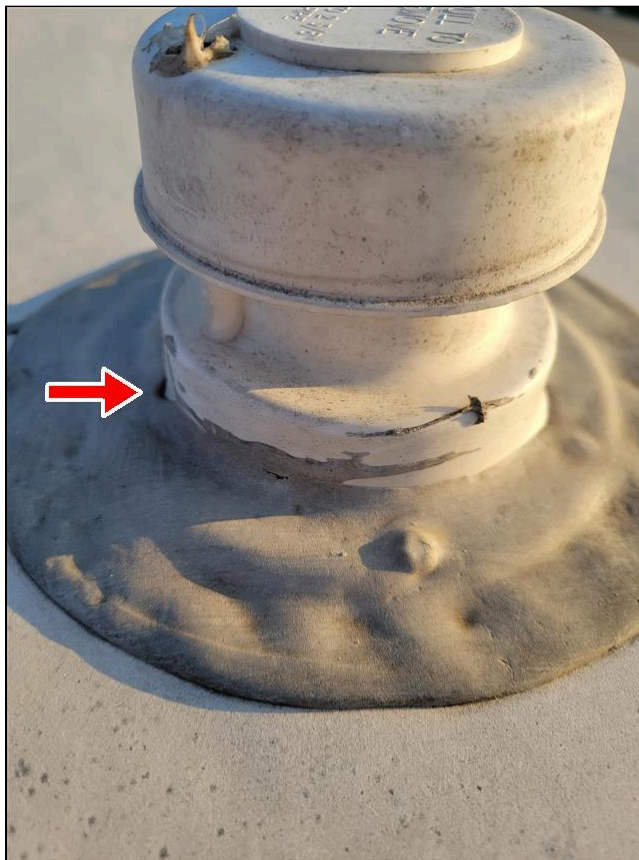
plumbing vent cover - rear

**2.7** (1) The inspector noted a potential water intrusion point on the front edge of the rear plumbing vent cover. The inspector noted inadequate sealant inside the retaining screw hole of the middle plumbing vent cap next to the skylight. It is recommended this be repaired by a qualified RV Technician.

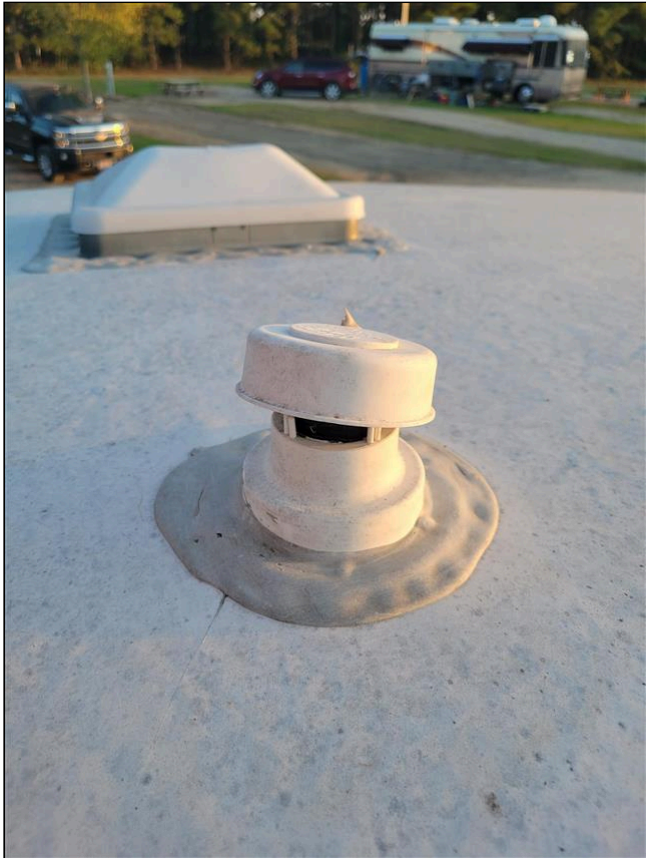
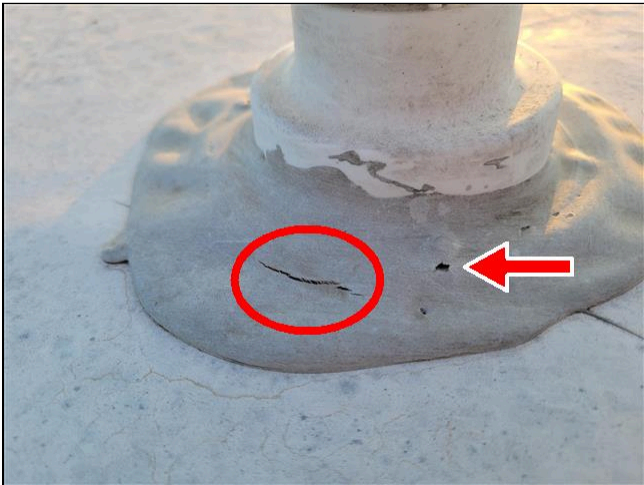
plumbing vent cap - front

(2) The inspector noted that the plumbing vent cap is not fully seated onto its base as well as two potential water intrusion points on the streetside edge of the sealant of the front most plumbing vent cap. It is recommended this be repaired by a qualified RV Technician.

2.7 (2) The inspector noted that the plumbing vent cap is not fully seated onto it's base as well as two potential water intrusion points on the streetside edge of the sealant of the front most plumbing vent cap. It is recommended this be repaired by a qualified RV Technician.

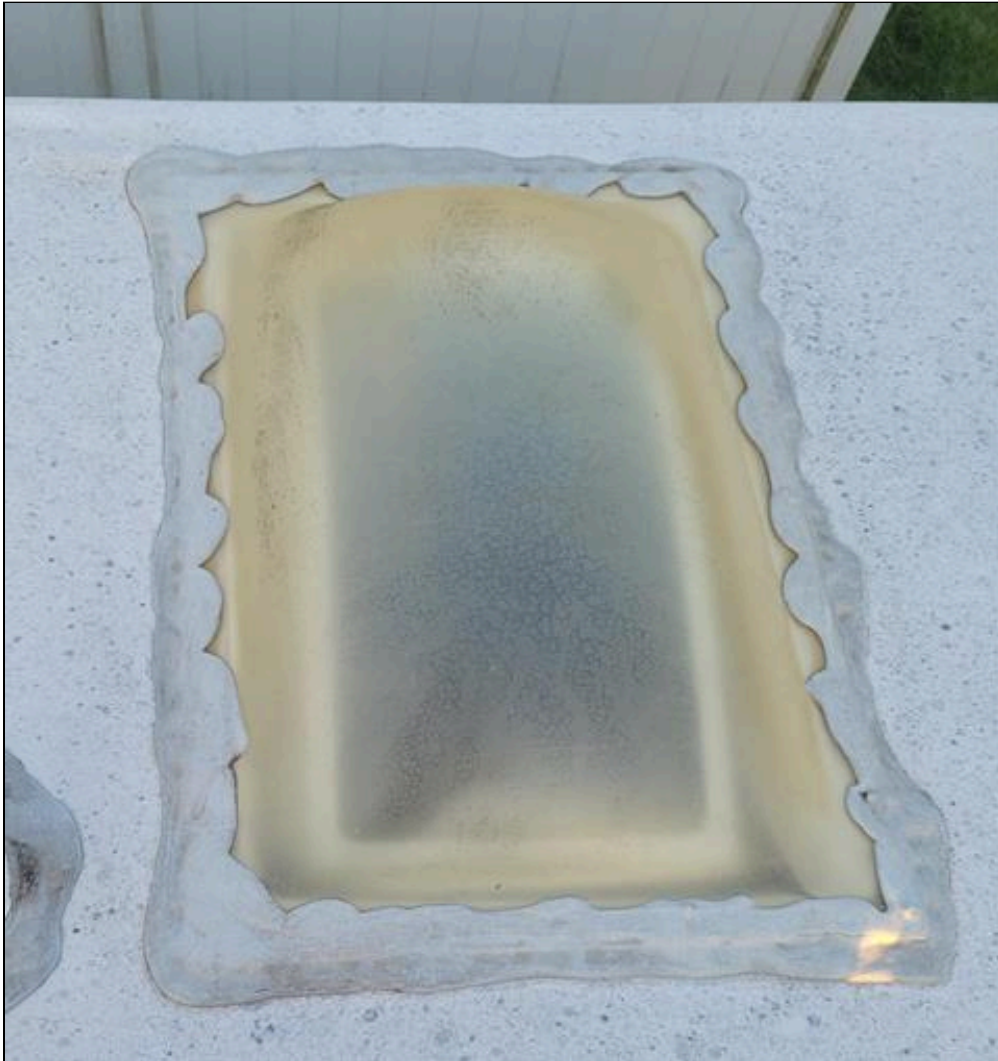
🔍 **2.8** (1) The inspector noted discoloration of the skylight above the shower. It is recommended this be evaluated at a later date for further deterioration. It is recommended this be repaired by a qualified RV Technician.

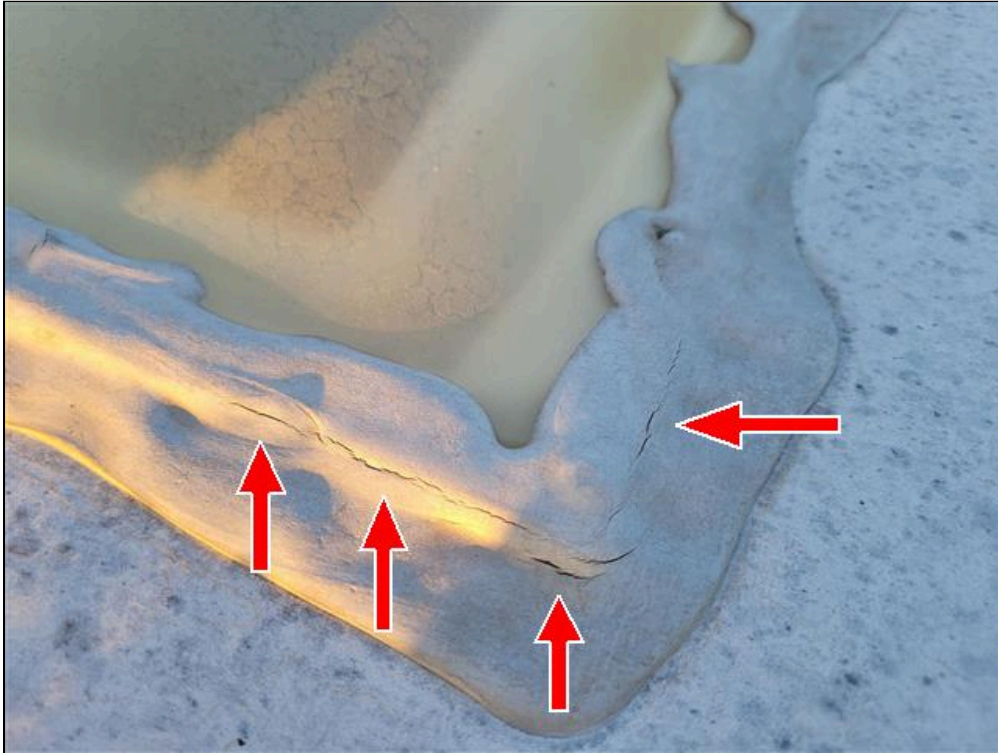
🔍 **2.8** (2) The inspector noted a crack in the sealant wrapping around the front curbside corner of the skylight.

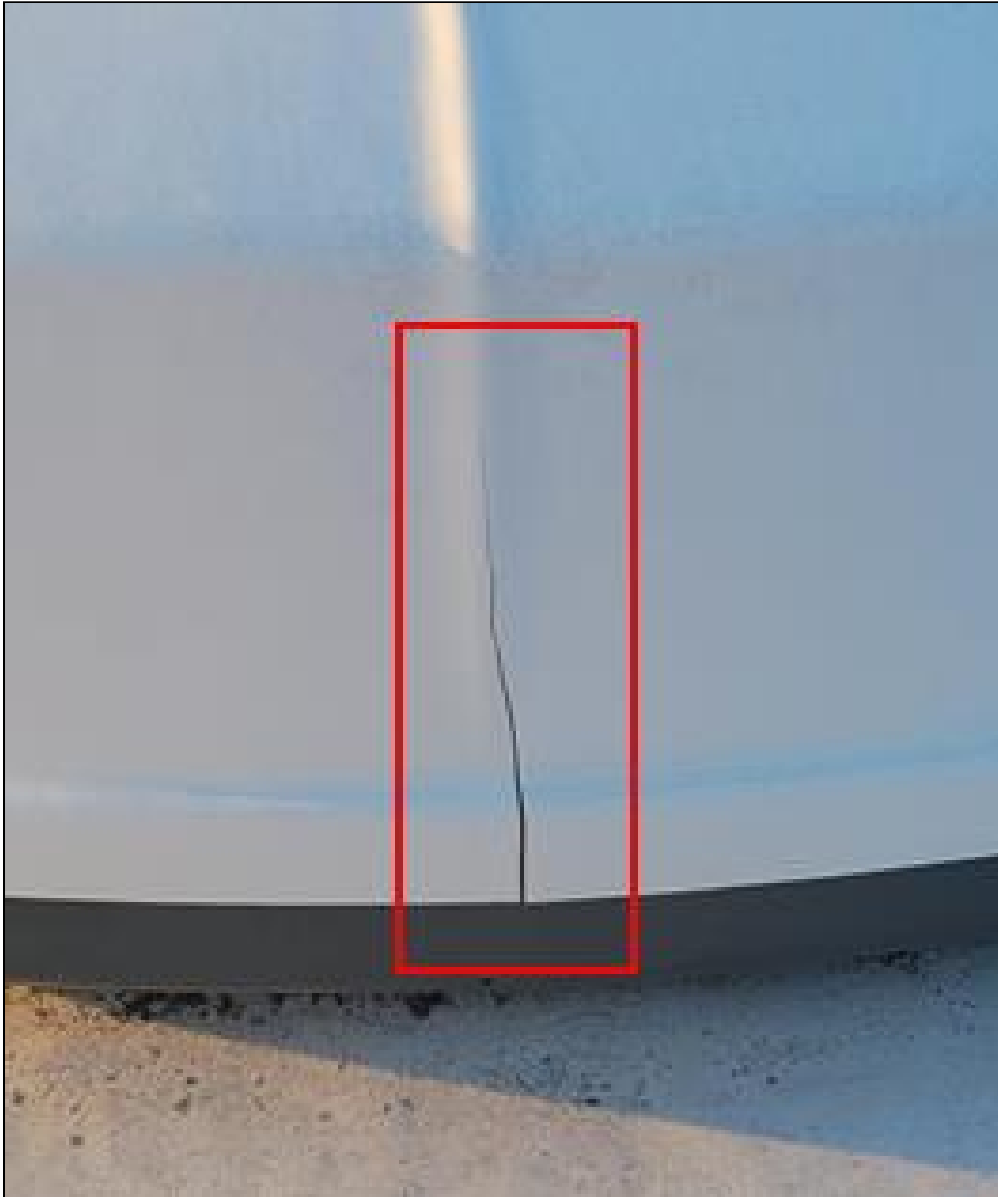
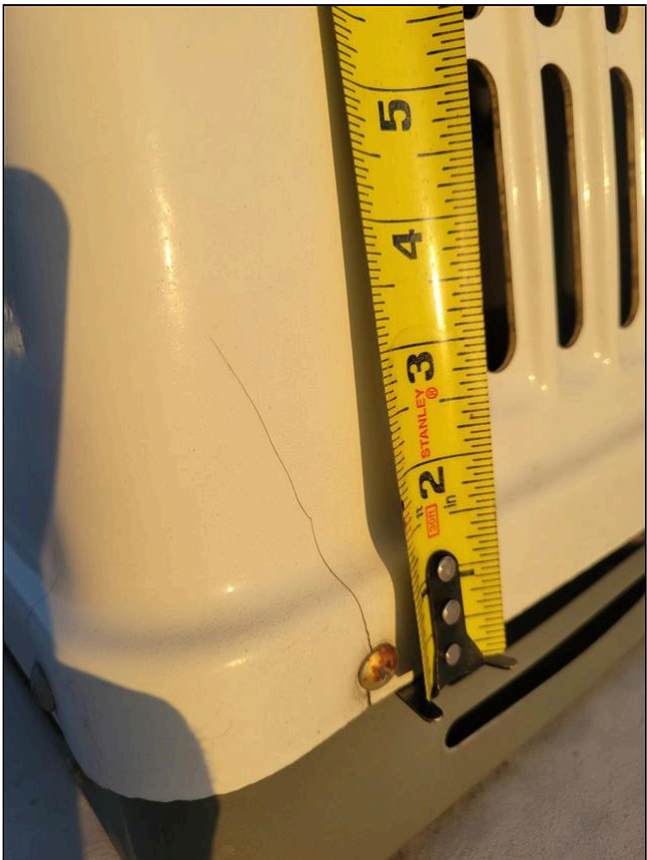
ac shroud - front edge

The inspector noted multiple cracks in the shroud of the air conditioning unit. The unit has a 6 inch crack in the center on the front edge, a 6 in crack on the top edge of the streetside, a 3 inch crack on the streetside lower rear corner, and a 3 inch crack on the curbside rear corner. This is a life safety issue due to the risk of the shroud coming loose/off during transport and causing a hazard on the road. It is recommended this be repaired by a qualified RV Technician.

**+** 2.9 The inspector noted multiple cracks in the shroud of the air conditioning unit. The unit has a 6 inch crack in the center on the front edge, a 6 in crack on the top edge of the streetside, a 3 inch crack on the streetside lower rear corner, and a 3 inch crack on the curbside rear corner. This is a life safety issue due to the risk of the shroud coming loose/off during transport and causing a hazard on the road. It is recommended this be repaired by a qualified RV Technician.

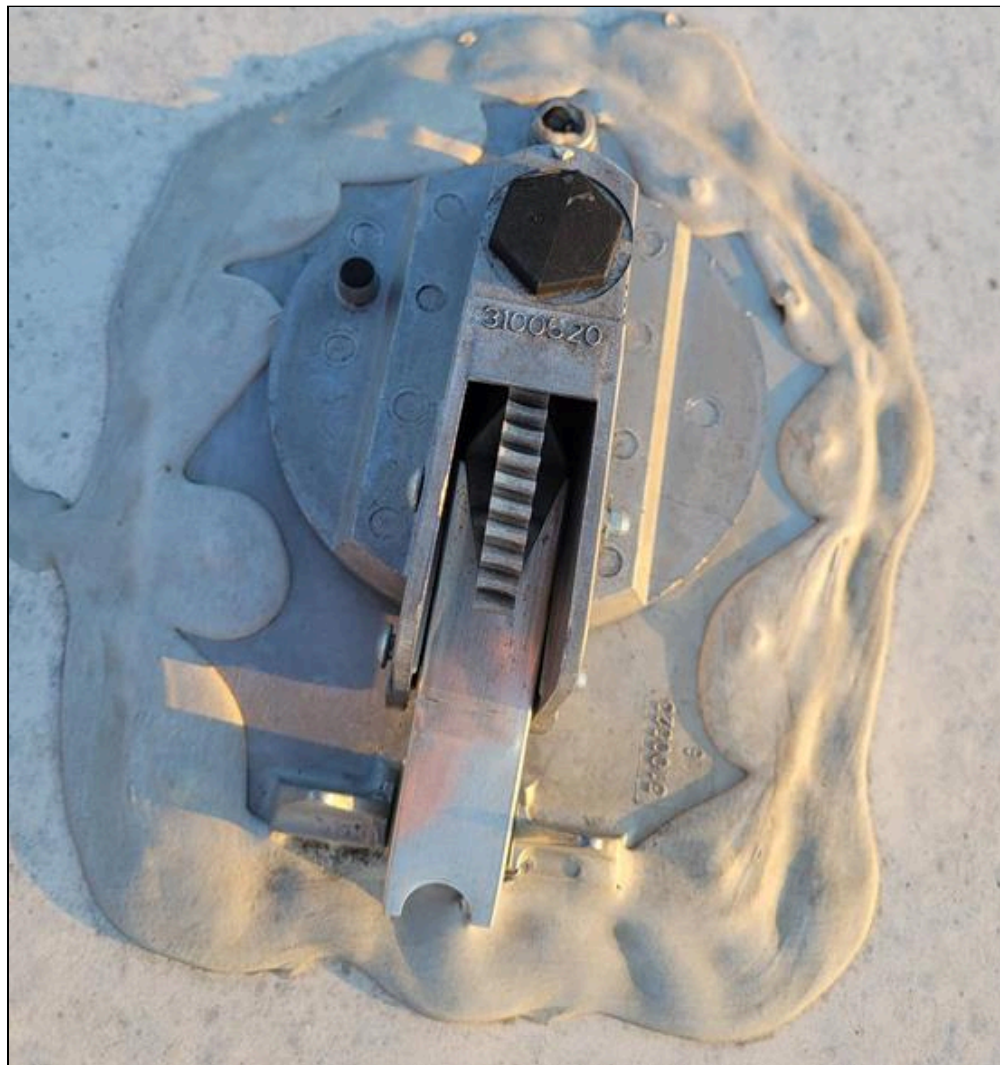
**2.11** The inspector noted a potential water intrusion point in the sealant on the curbside edge of the TV antenna base as well as no TV antenna was present. It is recommended this be repaired by a qualified RV Technician.

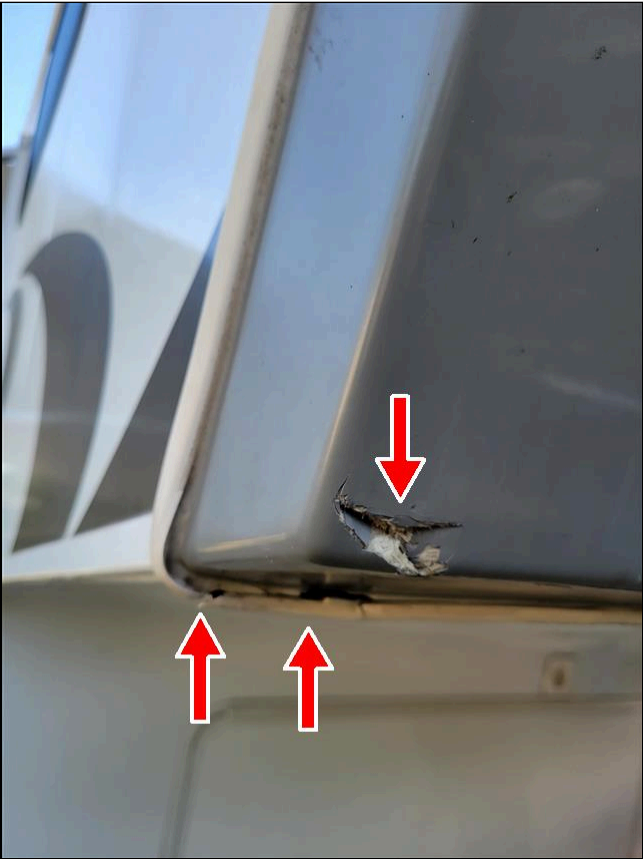
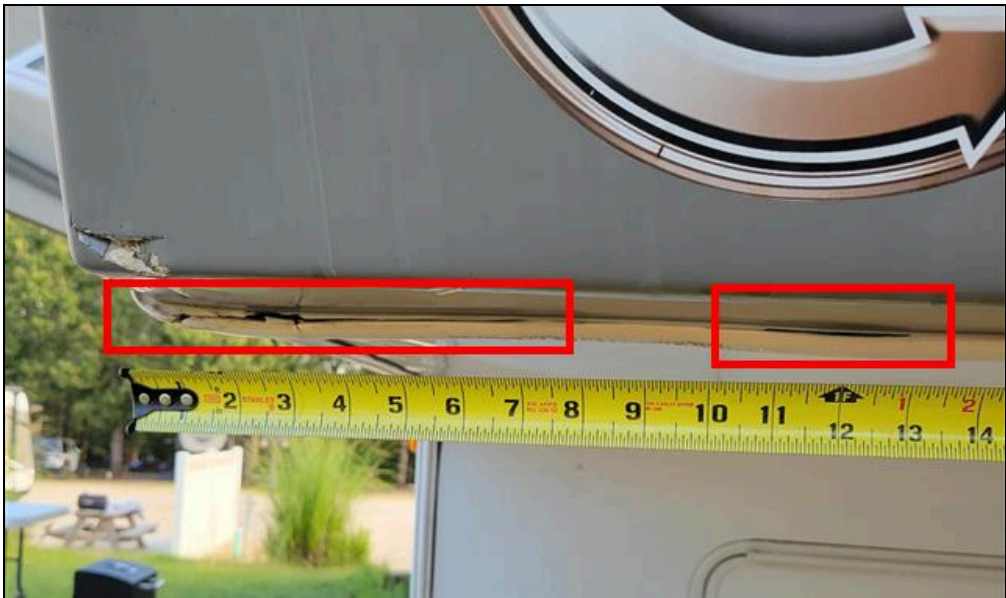
Front cap - curbside lower corner

(1) The inspector noted a crack in the fiberglass on the curbside lower corner as well as potential water intrusion point with loosened joint seal and sealant on the same corner. It is recommended this be repaired by a qualified RV Technician.

3.0.A (1) The inspector noted a crack in the fiberglass on the curbside lower corner as well as potential water intrusion point with loosened joint seal and sealant on the same corner. It is recommended this be repaired by a qualified RV Technician.

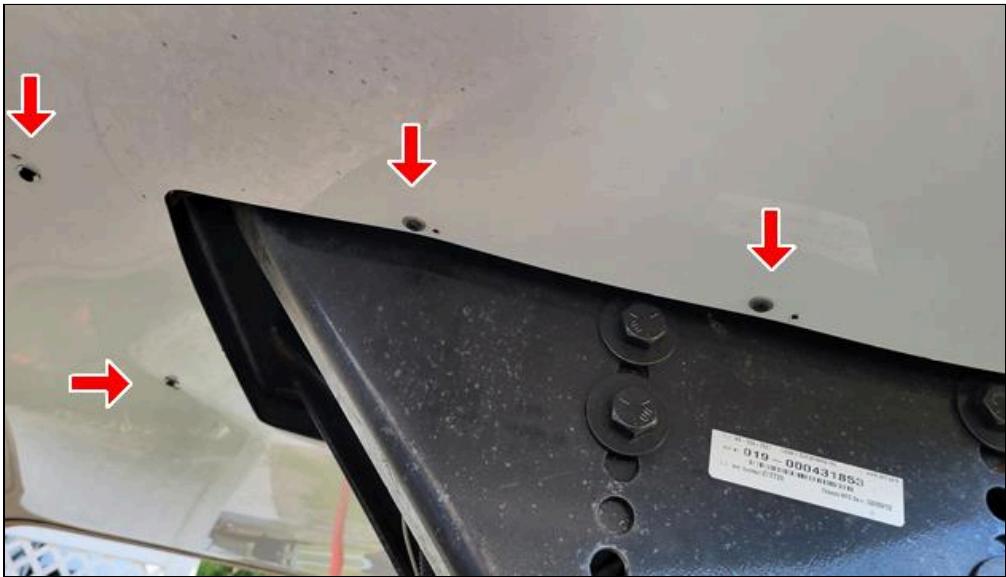
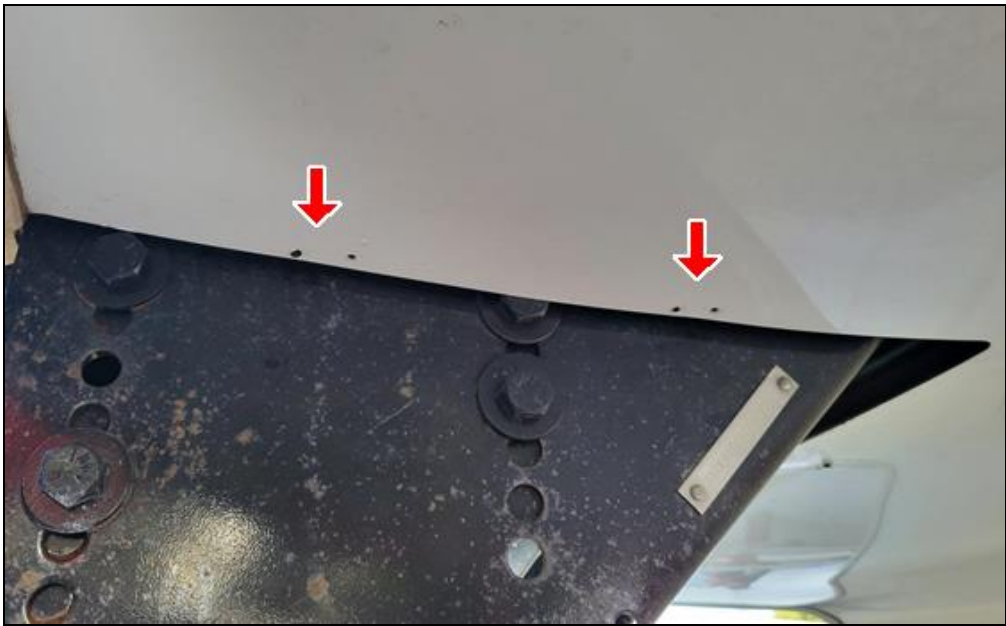
front cap - pinbox

3.0.A (2) The inspector noted non-OEM screws securing the plastic enclosure around the pinbox underneath the front cap.

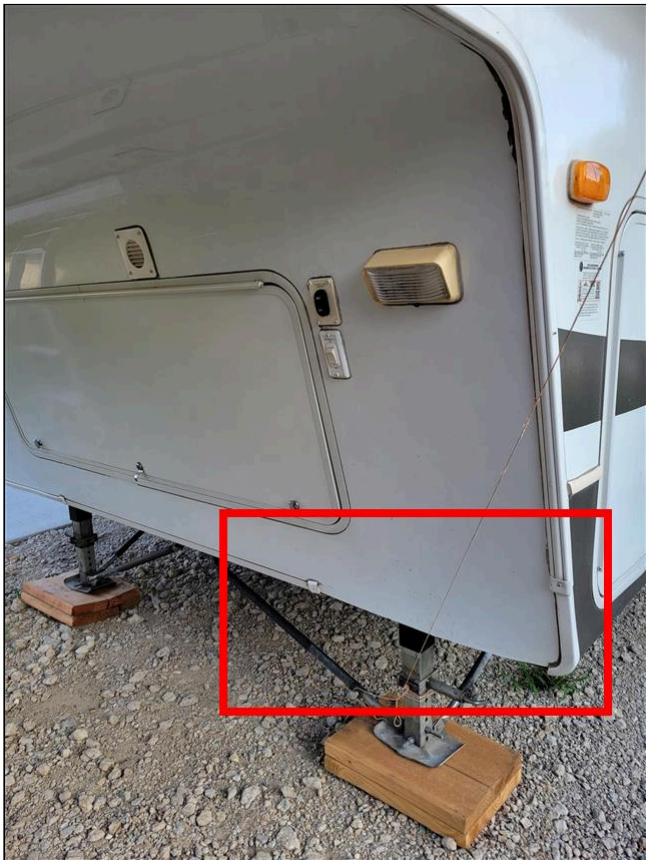
front cap - lower streetside corner

3.0.A (3) The inspector noted a missing trim piece on the lower streetside corner of the front cap. It is recommended this be repaired by a qualified RV Technician.

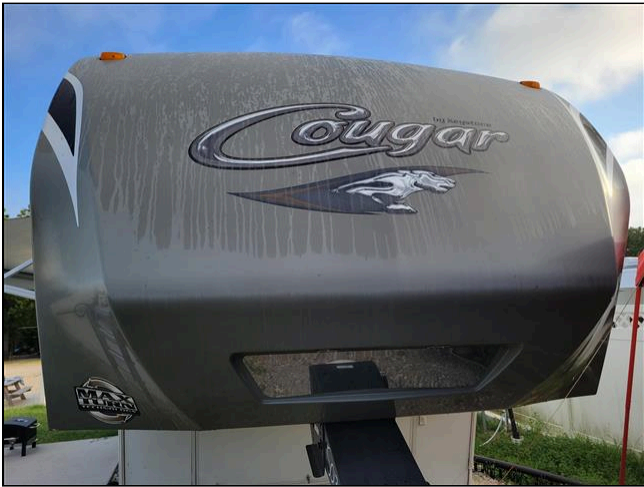
(4) The inspector noted fading of the paint on the leading face of the front cap. It is recommended this be repaired by a qualified RV Technician.

**3.0.A** (4) The inspector noted fading of the paint on the leading face of the front cap. It is recommended this be repaired by a qualified RV Technician.

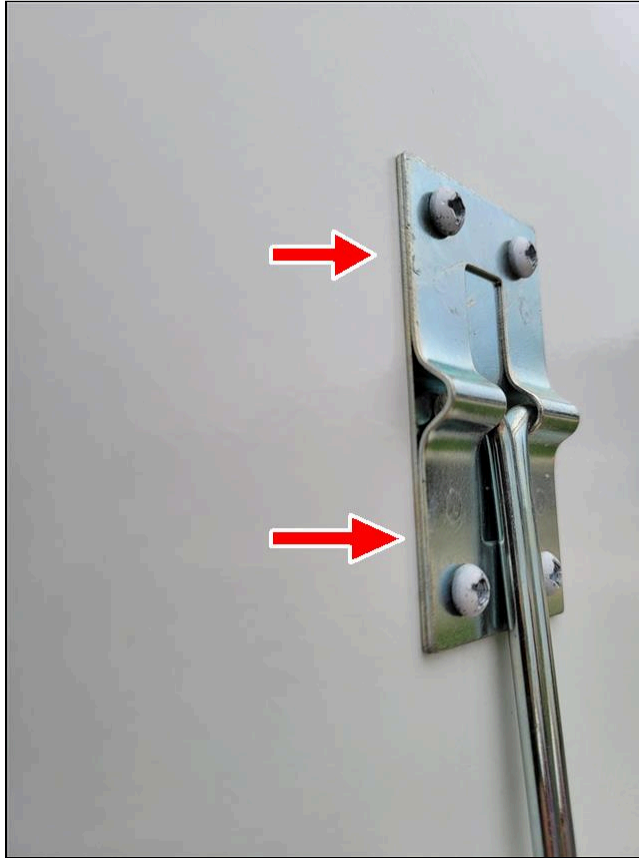
**3.0.B (1)** The Inspector noted a non-OEM door latch behind the front awning arm without any apparent sealant behind it. It is recommended this be repaired by a qualified RV Technician.

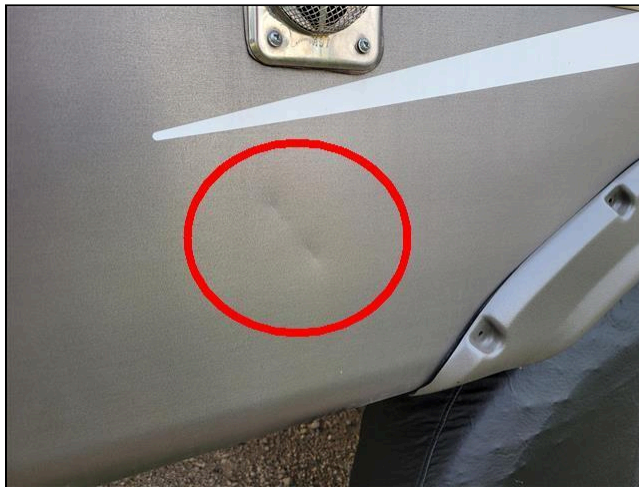
curbside - lower tin

**3.0.B (2)** The inspector noted a small dent in the tin behind the tire fender on the curbside sidewall.

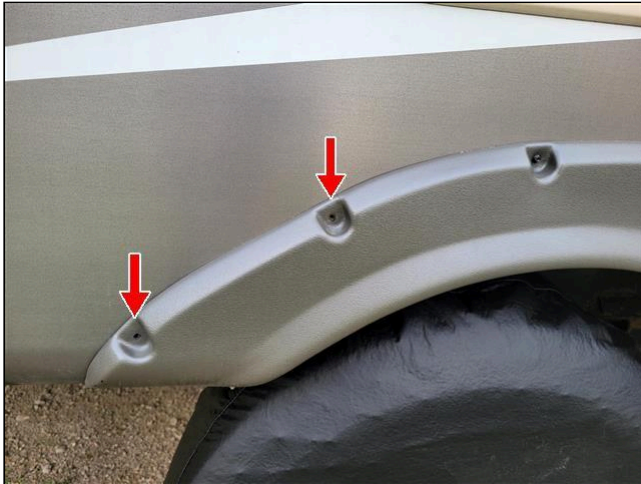
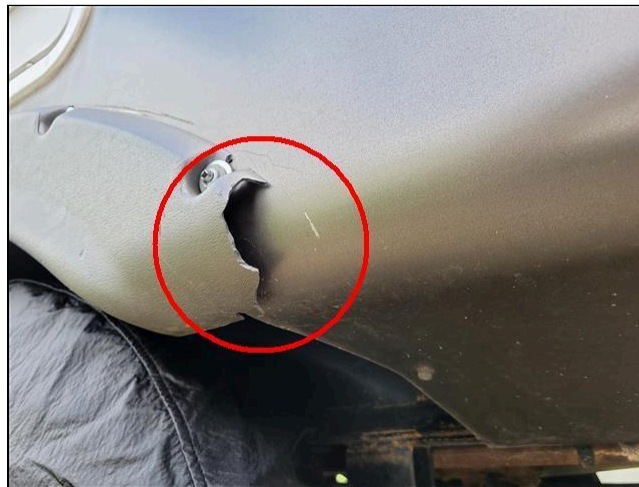
curbside - wheel fender

**3.0.B** (3) The inspector noted a broken off and missing piece on the front edge of the wheel fender, two missing screws on the rear, and 4 replaced screws with washers on the front edge of the curbside wheel fender. It is recommended this be repaired by a qualified RV Technician.

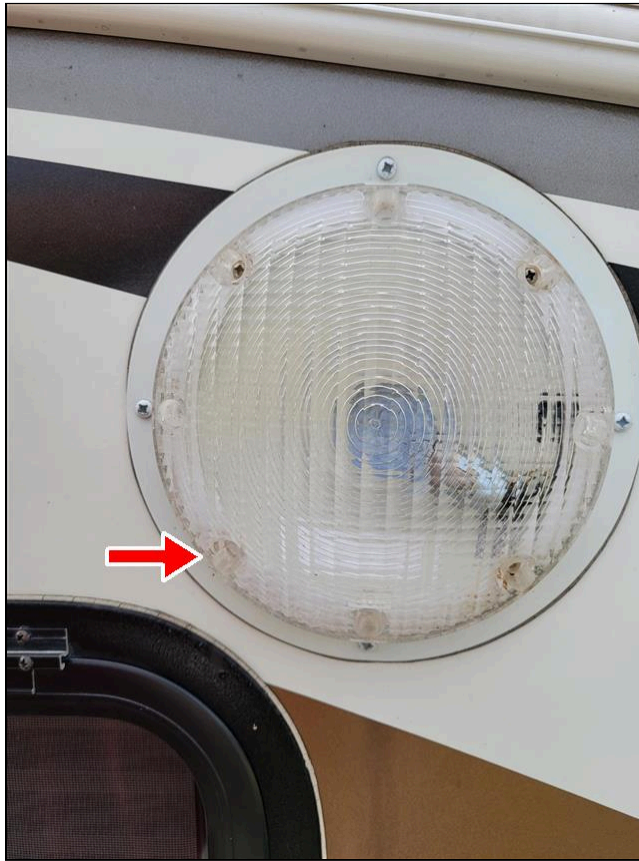
🔍 **3.0.B** (4) The inspector noted a single missing screw in the lower rear corner of the curbside spotlight.

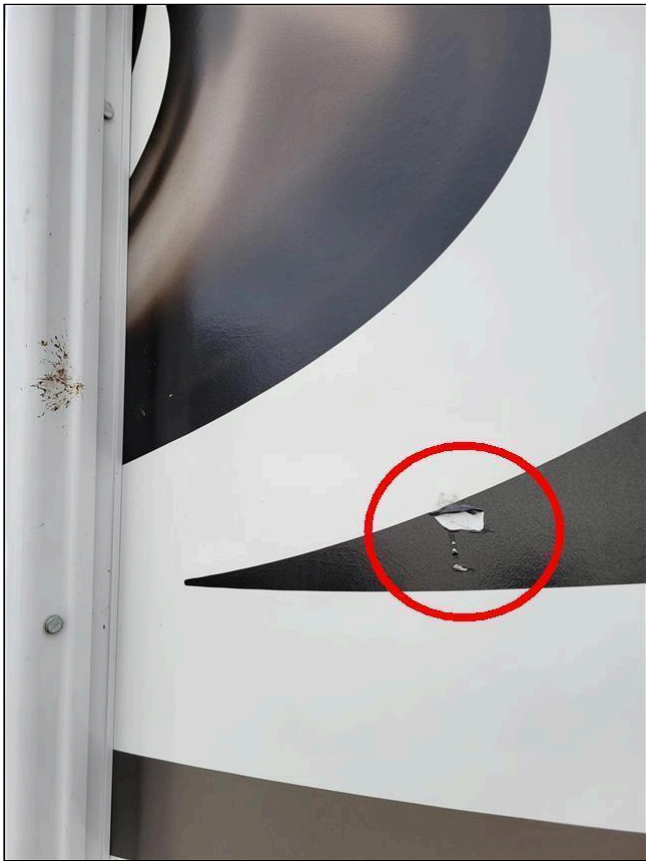
curbside - decal front

3.1.B The inspector noted marring in the decal to the front of the front awning arm on the curbside sidewall as well as discoloration of the decal above the water heater door on the curbside sidewall.
