# RV Inspection Report

**Inspection Date:** 1/19/2022

2012 Keystone Cougar 330RBK

**Suite Wheels RV Inspections and Services, LLC.**

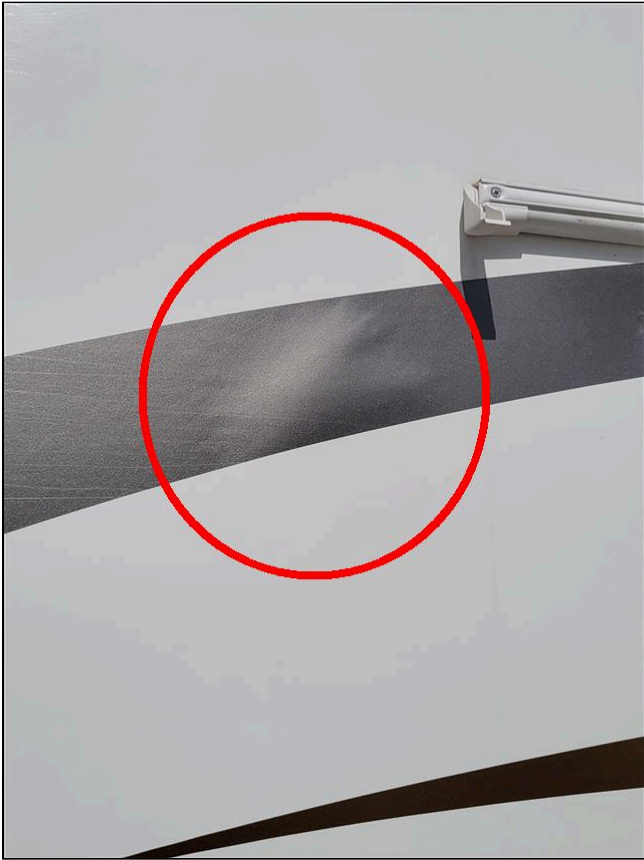
streetside - delamination

🔍 **3.0.C** The inspector noted an area of delamination directly in front and below the front edge of the gutter for the center slideout. Inspector recommends further evaluation by and RV Technician for further damage assessment.

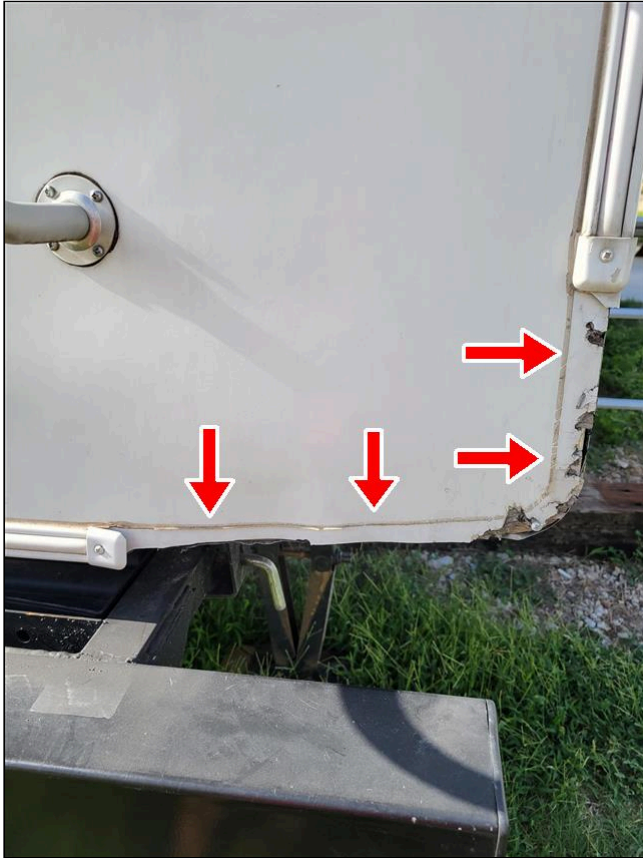
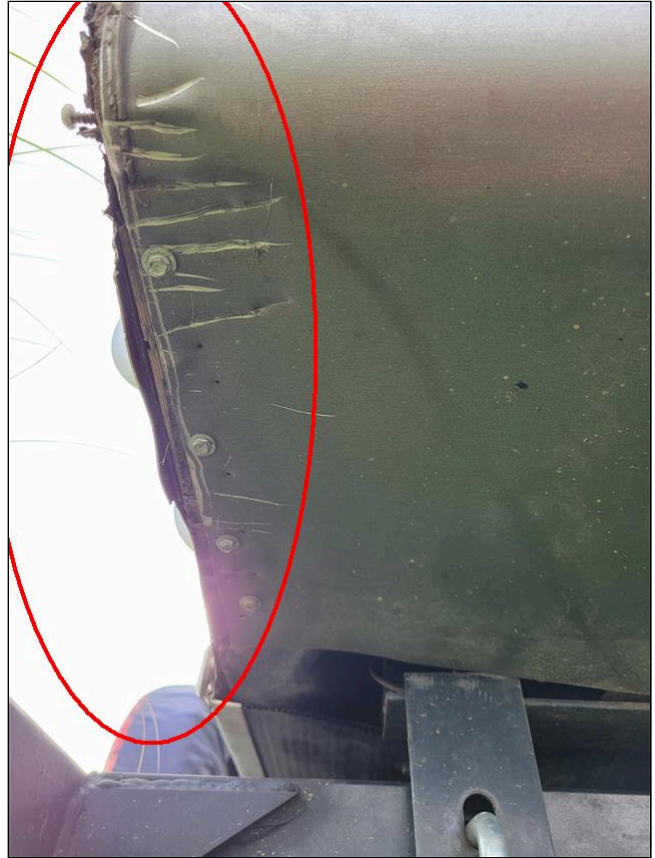
rear cap - lower curbside

**3.0.D** The inspector noted missing trim piece and damage to tin on the curbside lower corner of the rear cap. It is recommended this be repaired by a qualified RV Technician.

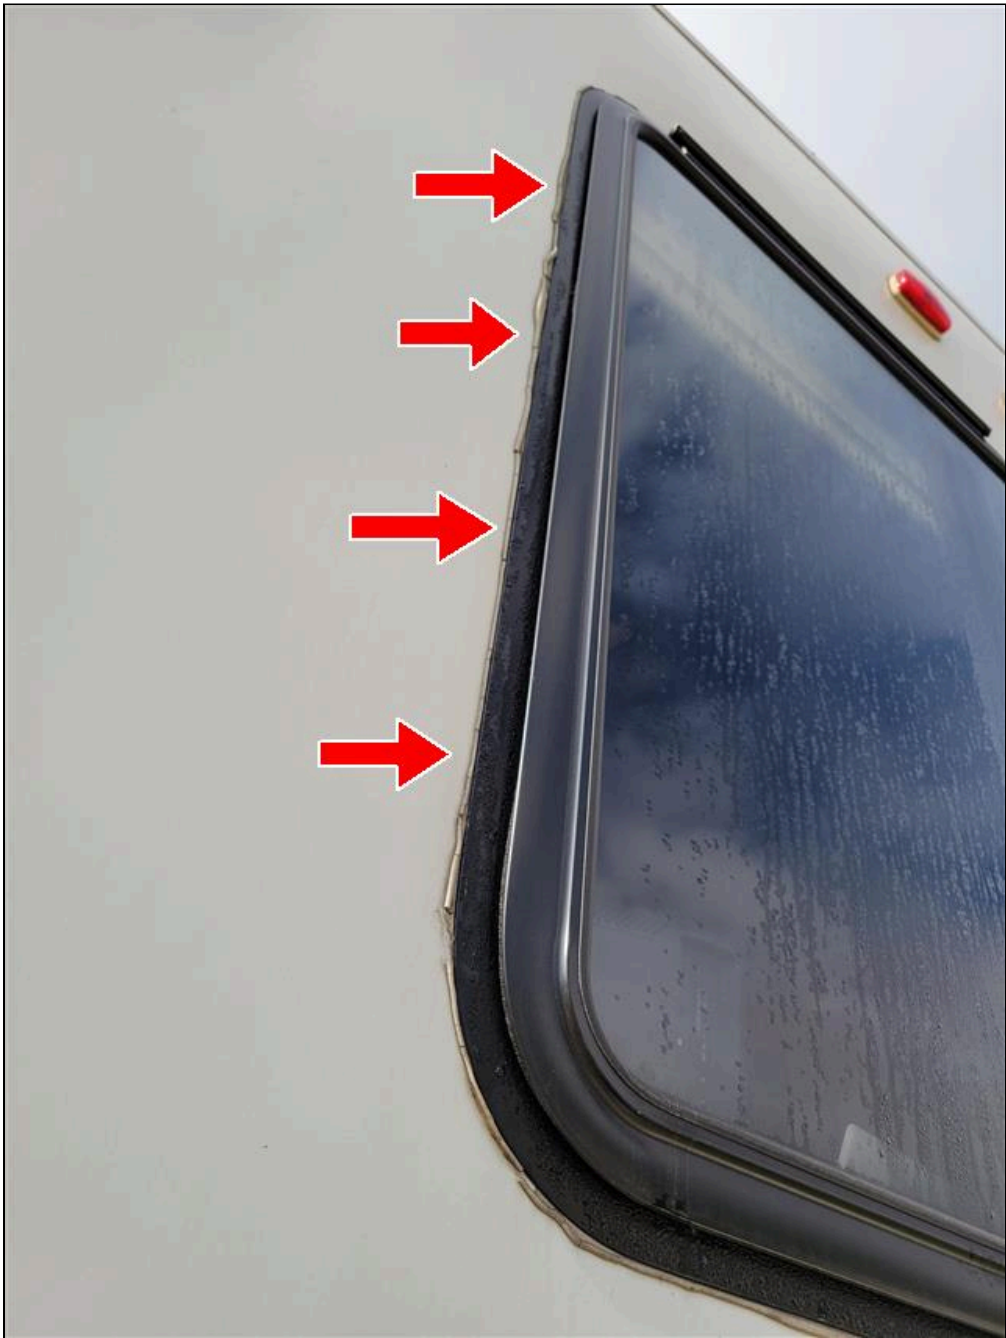
rear cap - window

Inspector noted deterioration of the sealant around the entire window on the rear cap. This is an emergency escape window making this a life safety issue. It is recommended this be repaired by a qualified RV Technician.

**+** **3.2.D** Inspector noted deterioration of the sealant around the entire window on the rear cap. This is an emergency escape window making this a life safety issue. It is recommended this be repaired by a qualified RV Technician.

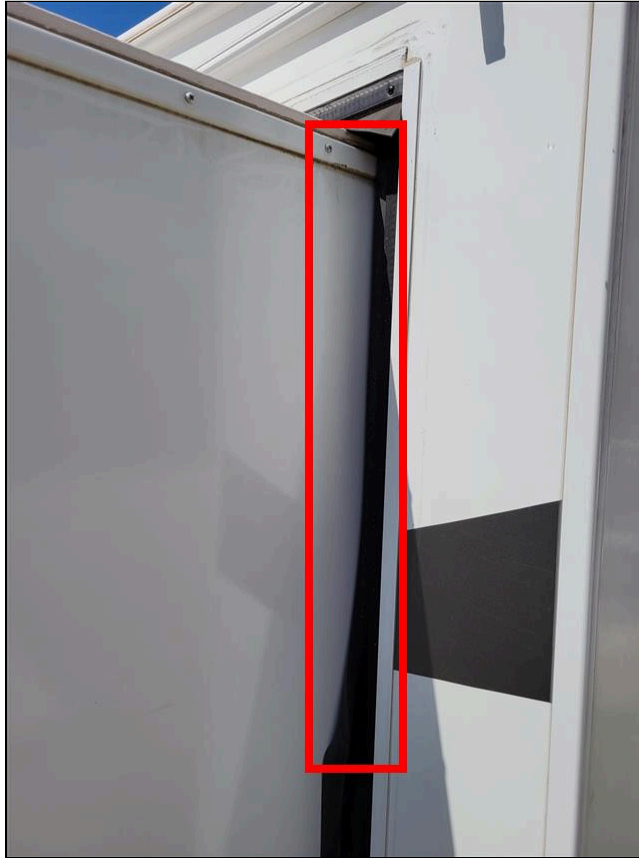
streetside -rear slideout rear edge

🔍 **6.2.A** (1) The inspector noted that the blade seal on the rear edge of the rear slideout did was not fully deployed. After moving the slideout in and out the seal properly deployed.

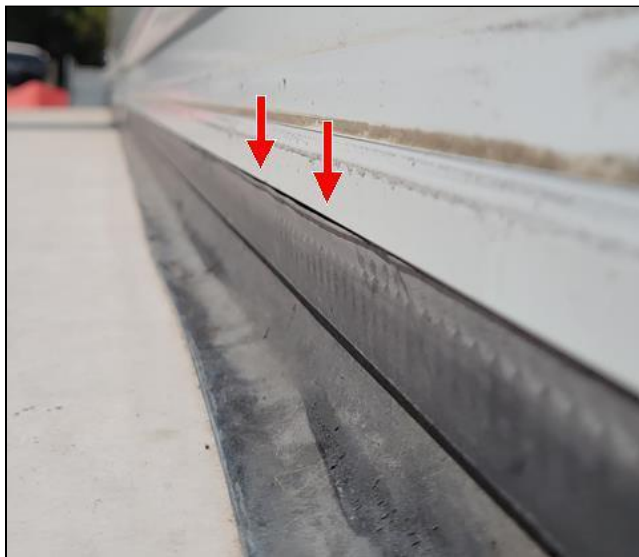
rear slideout -top bubble seal

**6.2.A** (2) The inspector noted that the top bubble seal has two potential water intrusion points approximately 2 feet in from the rear edge of the rear slideout. It is recommended this be repaired by a qualified RV Technician.

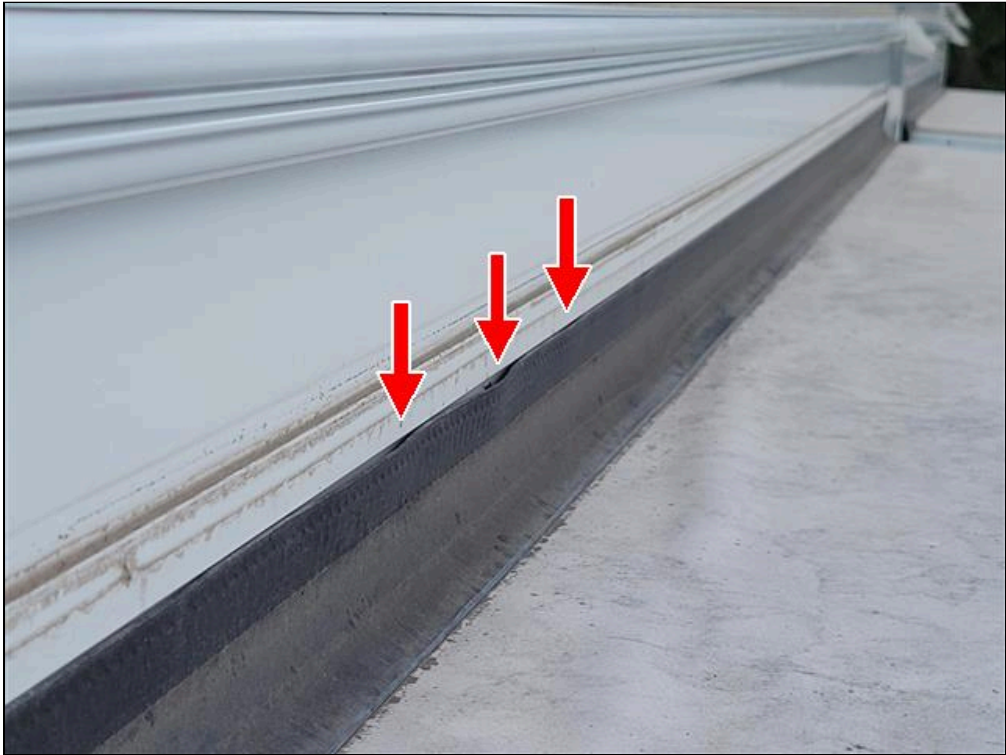
streetside center slideout - bubble seal top

6.2.B The inspector noted separation on the top bubble seal from the streetside sidewall above the center slideout approximately 2 feet back from the front edge of the streetside center slideout. It is recommended this be repaired by a qualified RV Technician.

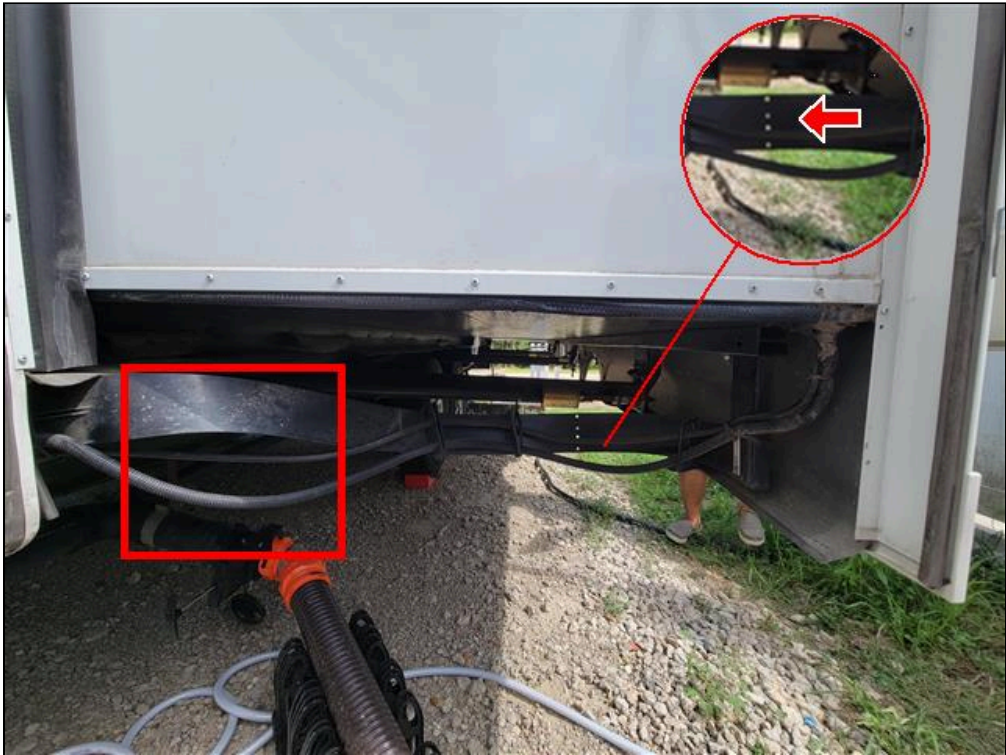
Streetside - center slideout wires

The inspector noted that the wiring harness underneath the front edge of the streetside center slideout is loose from it's connection at two points on the retraction track. If left, this could result frayed wiring

causing a hot skin issue creating life safety concern. It is recommended this be repaired by a qualified RV Technician.

**+** 6.4.B The inspector noted that the wiring harness underneath the front edge of the streetside center slideout is loose from it's connection at two points on the retraction track. If left, this could result frayed wiring causing a hot skin issue creating life safety concern. It is recommended this be repaired by a qualified RV Technician.

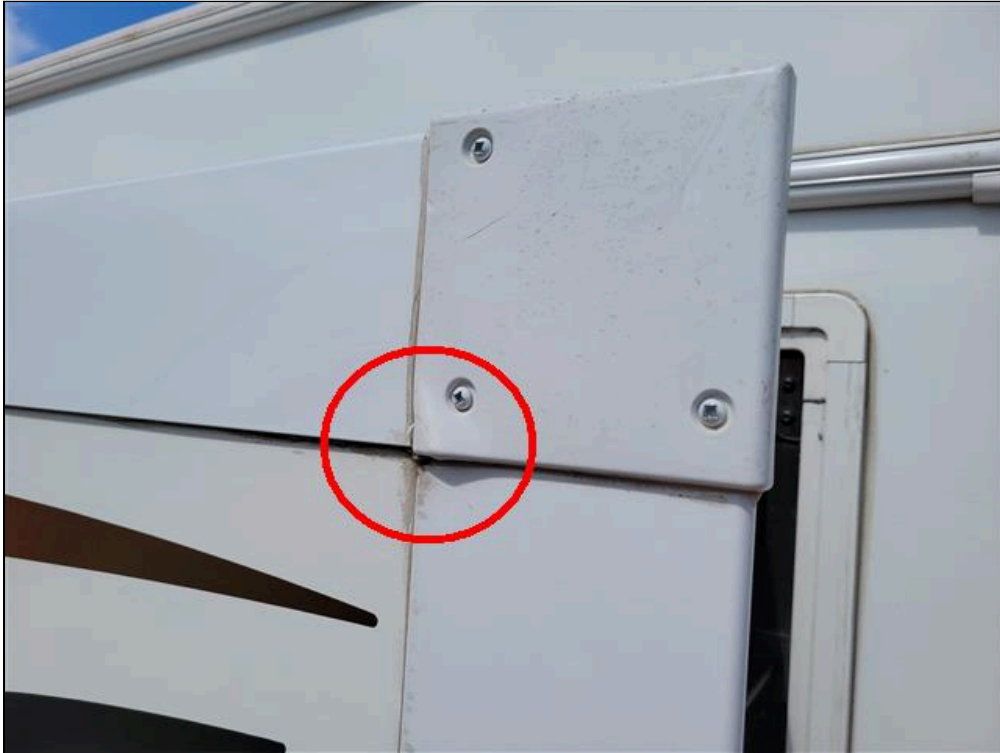
front slideout - t-molding

**6.1.C** The inspector noted damage to the upper rear t-molding corner on the front slideout. It is recommended this be repaired by a qualified RV Technician.

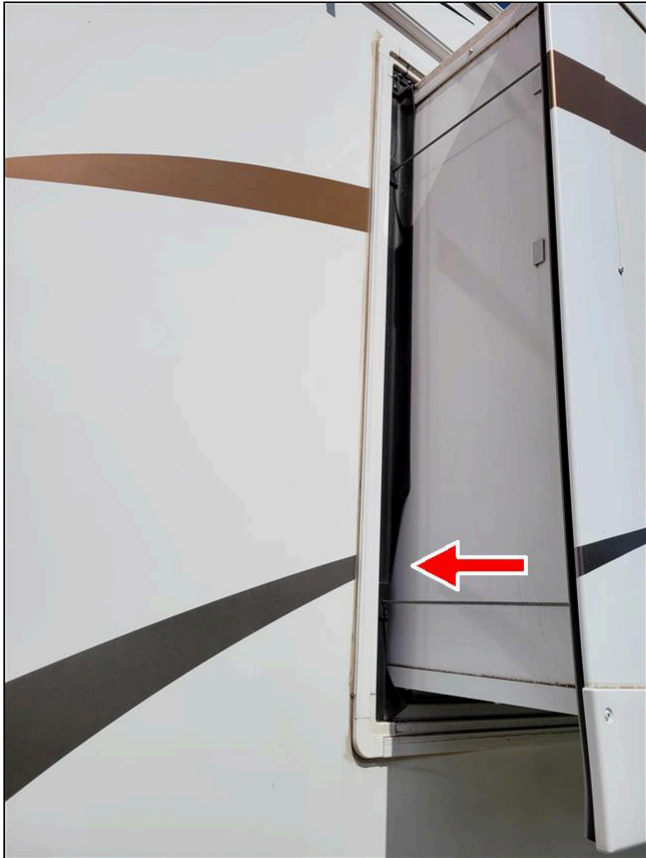
front slideout - front blade seal

The inspector noted that the blade seal on the front edge of the of the front slideout is not fully deployed in the lower corner as well as the upper corner of the rear edge of the front slideout, suggesting the slide out is out of alignment. It is recommended this be repaired by a qualified RV Technician.

**6.6.C** The inspector noted that the blade seal on the front edge of the of the front slideout is not fully deployed in the lower corner as well as the upper corner of the rear edge of the front slideout, suggesting the slide out is out of alignment. It is recommended this be repaired by a qualified RV Technician.

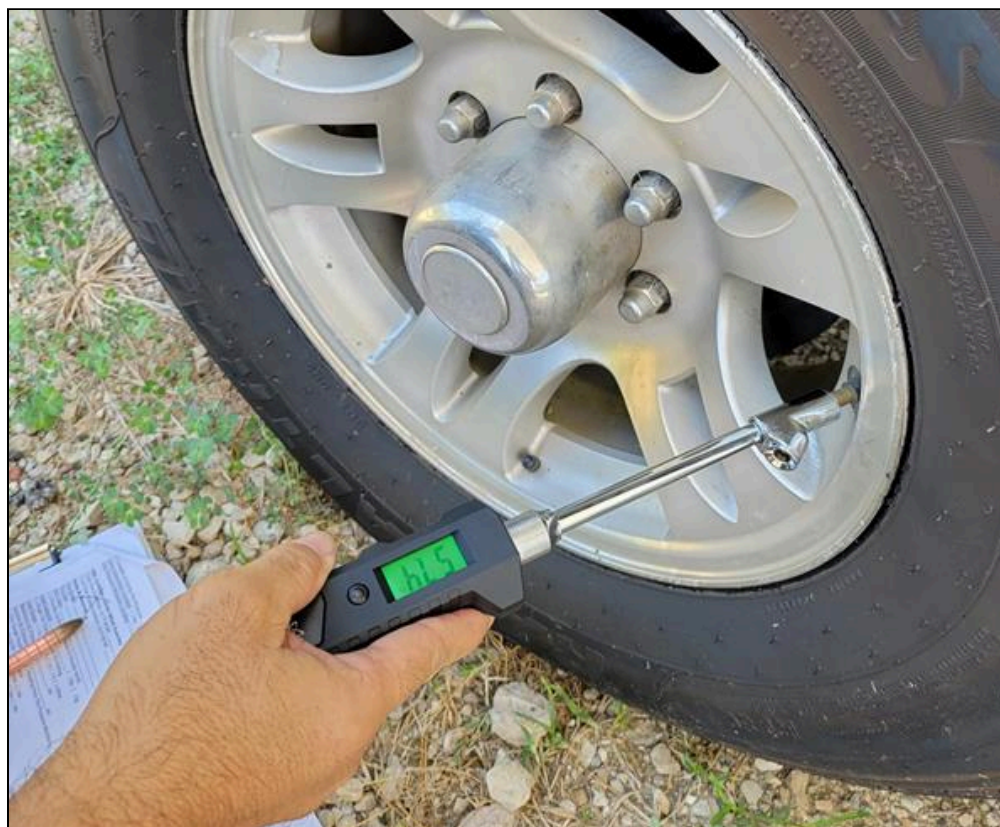
tire pressure - curbside rear

The inspector noted new tires were installed but the current air pressure in the tires is significantly low. This can result in a blow out of the tire while operating the vehicle. It is recommended this be fixed by a qualified tire expert before use of the vehicle.

**+** **7.0.B** The inspector noted new tires were installed but the current air pressure in the tires is significantly low. This can result in a blow out of the tire while operating the vehicle. It is recommended this be fixed by a qualified tire expert before use of the vehicle.

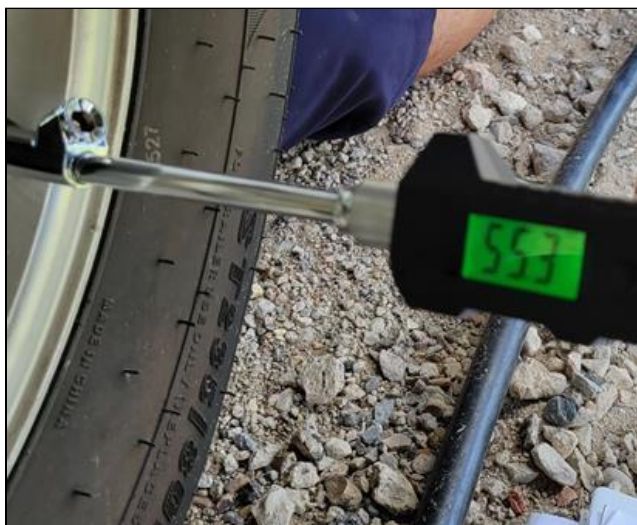
tire pressure - streetside rear

The inspector noted new tires were installed but the current air pressure in the tires is significantly low. This can result in a blow out of the tire while operating the vehicle. It is recommended this be fixed by a qualified tire expert before use of the vehicle.

**+** **7.0.C** The inspector noted new tires were installed but the current air pressure in the tires is significantly low. This can result in a blow out of the tire while operating the vehicle. It is recommended this be fixed by a qualified tire expert before use of the vehicle.

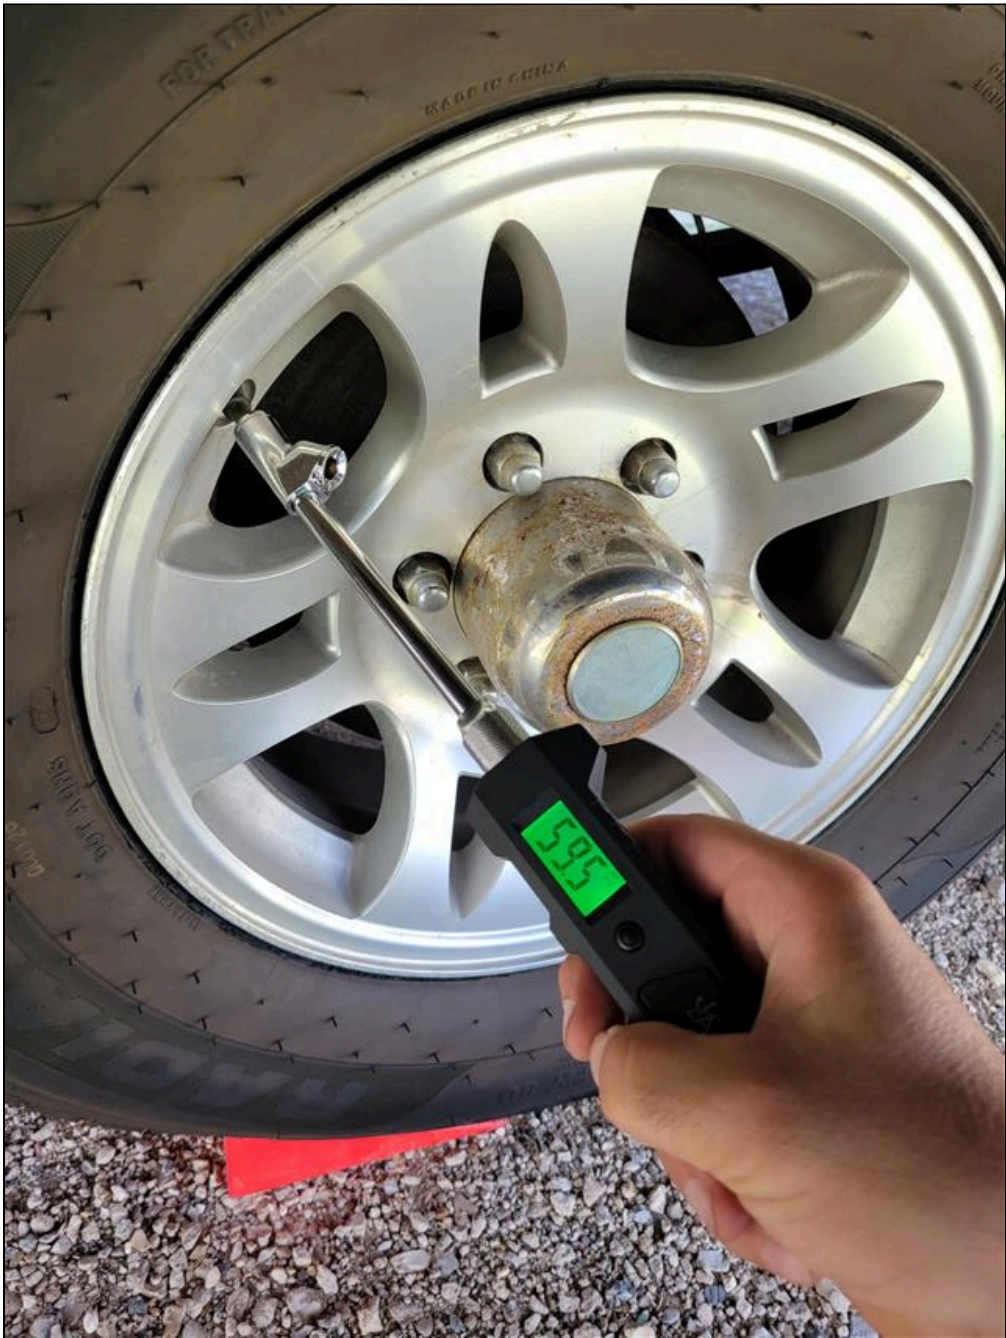
tire pressure - streetside front

The inspector noted new tires were installed but the current air pressure in the tires is significantly low. This can result in a blow out of the tire while operating the vehicle. It is recommended this be fixed by a qualified tire expert before use of the vehicle.

**7.0.D** The inspector noted new tires were installed but the current air pressure in the tires is significantly low. This can result in a blow out of the tire while operating the vehicle. It is recommended this be fixed by a qualified tire expert before use of the vehicle.

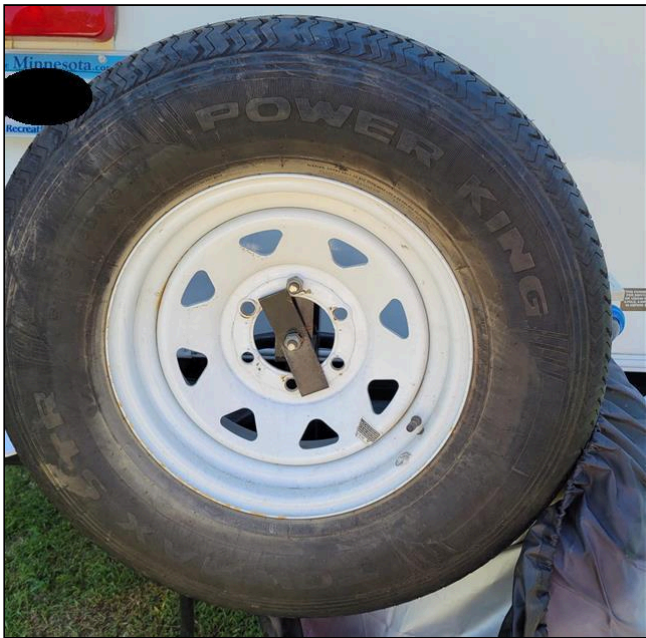
spare tire - brand

The inspector noted the spare tire installed on the rear bumper was past the 5 year date renewal by the DOT and the current air pressure in the tires is significantly low. This can result in a blow out of the tire while operating the vehicle. It is recommended this be fixed by a qualified tire expert before use of the vehicle.

**7.0.E** The inspector noted the spare tire installed on the rear bumper was past the 5 year date renewal by the DOT and the current air pressure in the tires is significantly low. This can result in a blow out of the tire while operating the vehicle. It is recommended this be fixed by a qualified tire expert before use of the vehicle.

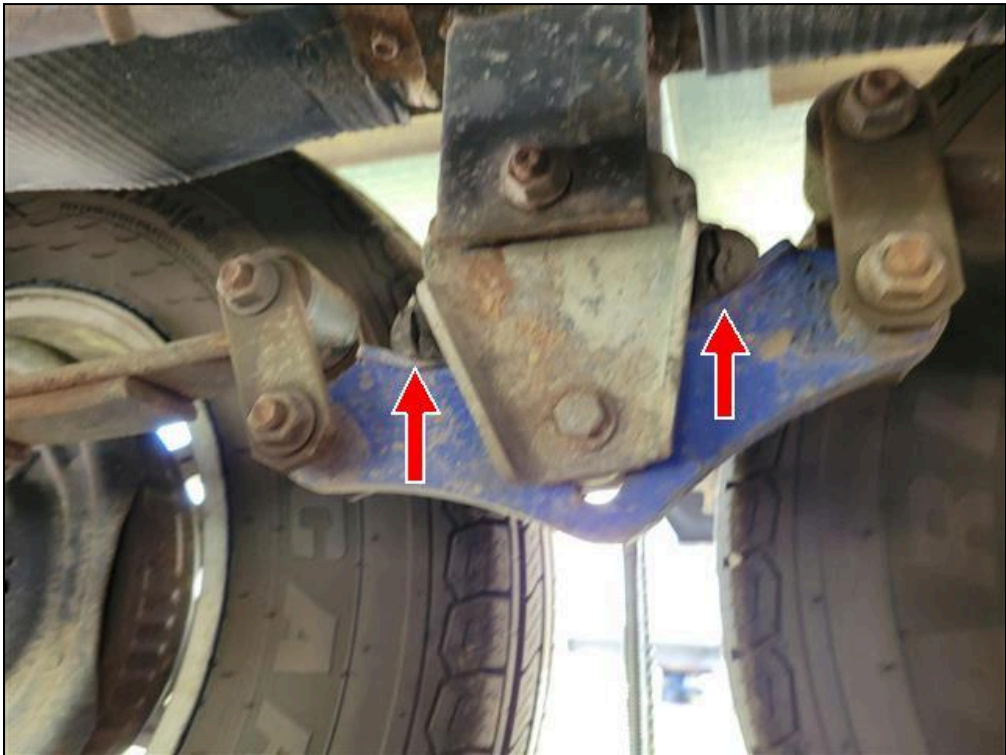
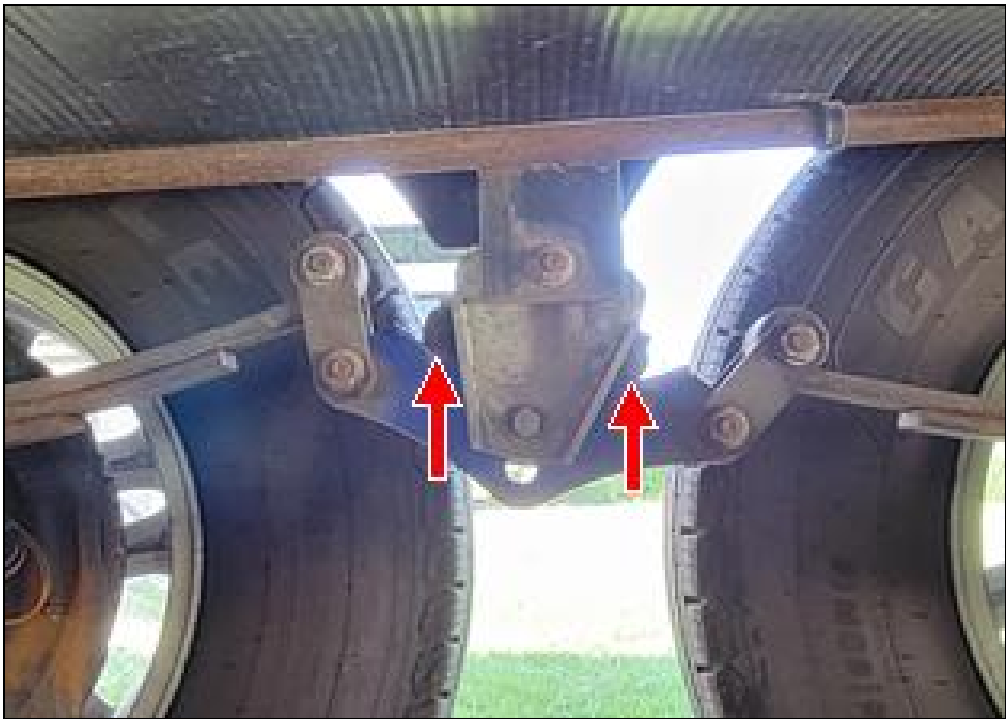
(1) The inspector noted cracking in the rubber bushing of the streetside and curbside shackle hangers. It is recommended this be repaired by a qualified RV Technician.

8.0 (1) The inspector noted cracking in the rubber bushing of the streetside and curbside shackle hangers. It is recommended this be repaired by a qualified RV Technician.

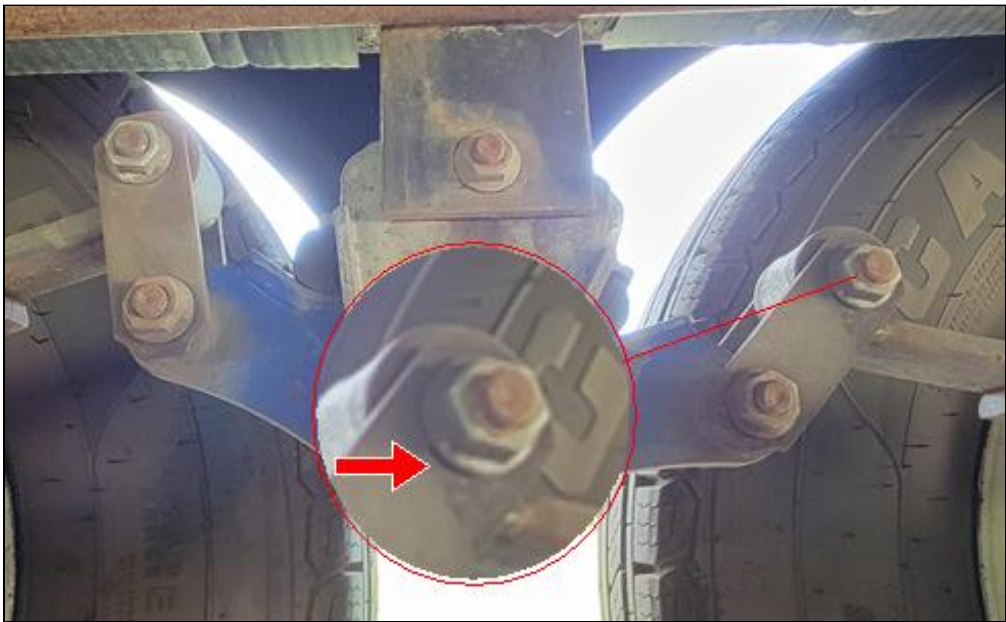
Curbside shackle

(2) The inspector noted wear on the shackle bolts sleeves sighting off-center positioning of the shackle bolt on the curbside shackle. While in transit, this breaking, could result in life-safety issue. It is recommended this be repaired by a qualified RV Technician.

**8.0** (2) The inspector noted wear on the shackle bolts sleeves sighting off-center positioning of the shackle bolt on the curbside shackle. While in transit, this breaking, could result in life-safety issue. It is recommended this be repaired by a qualified RV Technician.

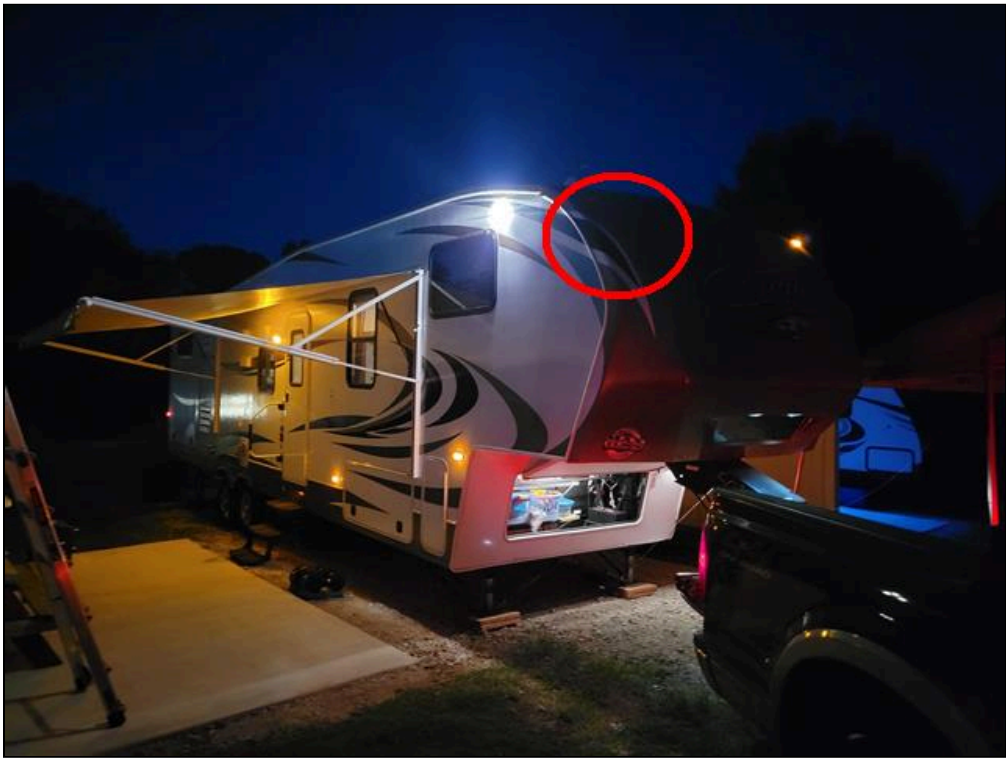
Clearance light - curbside front

10.2 The inspector noted a non-functioning amber clearance light at the upper curbside of the front of the vehicle. It is recommended this be repaired by a qualified RV Technician.

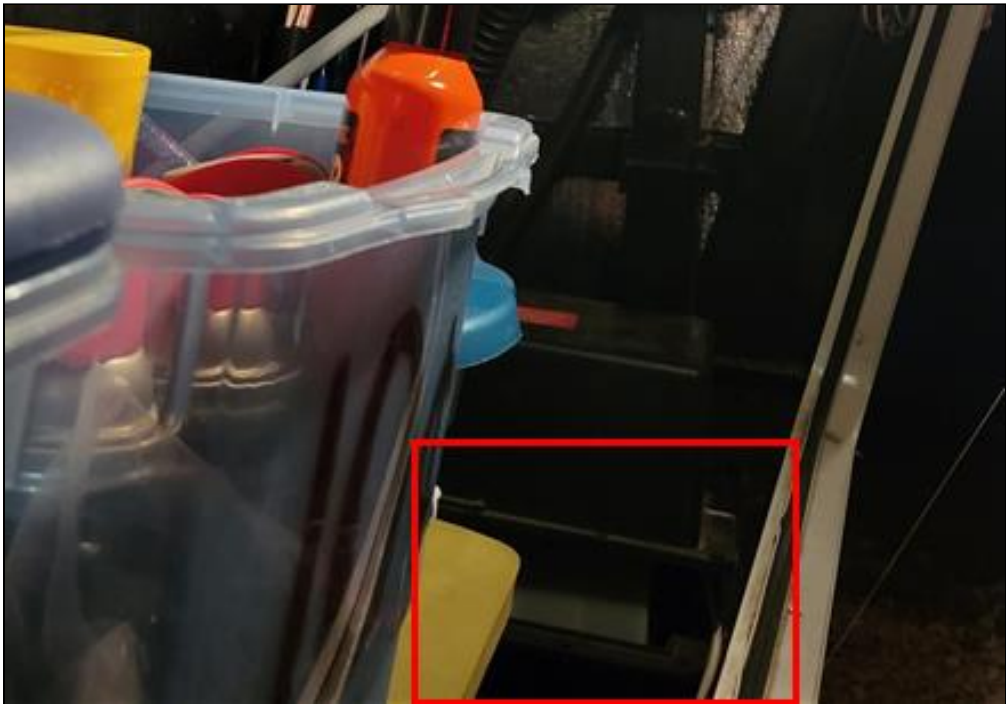
battery box not secured

The inspector noted that the top of the battery box is not secure to the base of the battery box in the front basement on the streetside. This does not provide proper ventilation for hydrogen and oxygen (explosive and toxic) gases to escape the cabin which can then make their way into the living quarters/ bedroom. It is recommended this be repaired by a qualified RV Technician.

**11.30** The inspector noted that the top of the battery box is not secure to the base of the battery box in the front basement on the streetside. This does not provide proper ventilation for hydrogen and oxygen (explosive and toxic) gases to escape the cabin which can then make their way into the living quarters/ bedroom. It is recommended this be repaired by a qualified RV Technician.

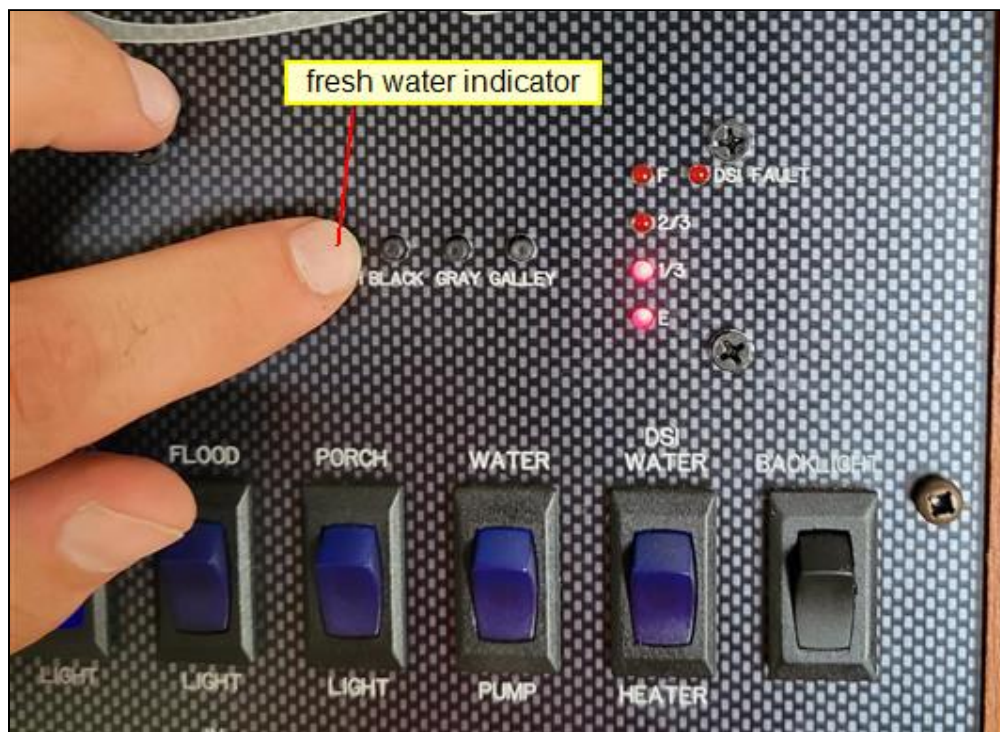
fresh water tank monitor

The inspector noted that the black and galley water level monitor system did not go to zero after the system was emptied. The black tank monitored at 3/4 full remaining and the galley tank monitored at 1/2 full remaining. The inspector noted that the fresh water system was not fully drained during the testing. It is recommended this be repaired by a qualified RV Technician.

**12.8** The inspector noted that the black and galley water level monitor system did not go to zero after the system was emptied. The black tank monitored at 3/4 full remaining and the galley tank monitored at 1/2 full remaining. The inspector noted that the fresh water system was not fully drained during the testing. It is recommended this be repaired by a qualified RV Technician.

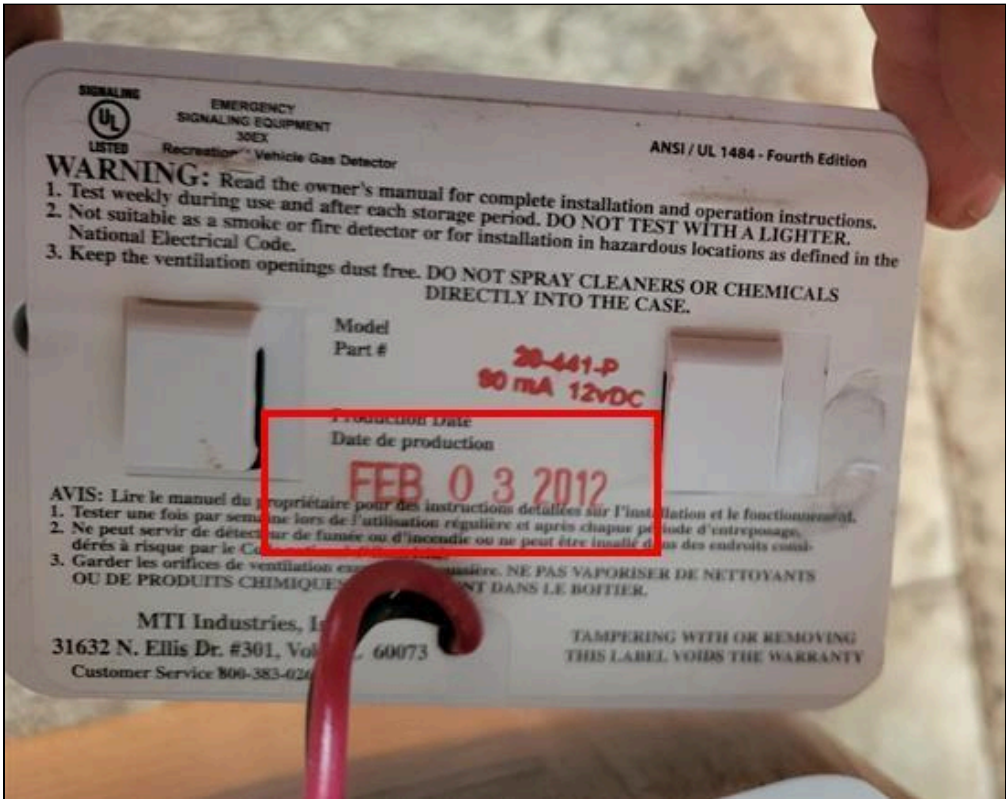
propane detector

The inspector noted that the LP detector in the galley area near the power panel has an expiration date greater than the 60 month recommended replacement per NFPA 1192-31 for manufacturers requirements. It is recommended this be repaired by a qualified RV Technician before the vehicle is occupied.

**13.2** The inspector noted that the LP detector in the galley area near the power panel has an expiration date greater than the 60 month recommended replacement per NFPA 1192-31 for manufacturers requirements. It is recommended this be repaired by a qualified RV Technician before the vehicle is occupied.

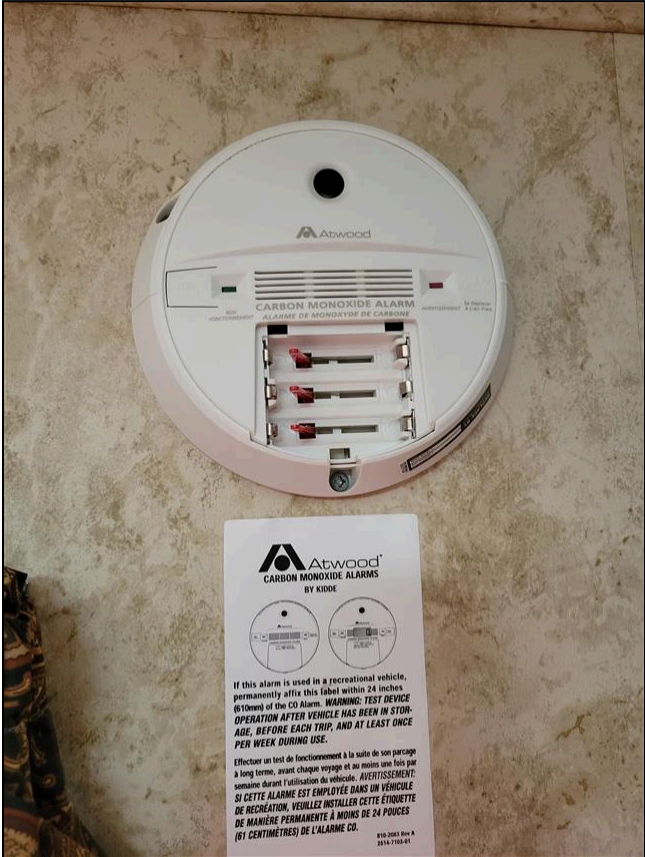
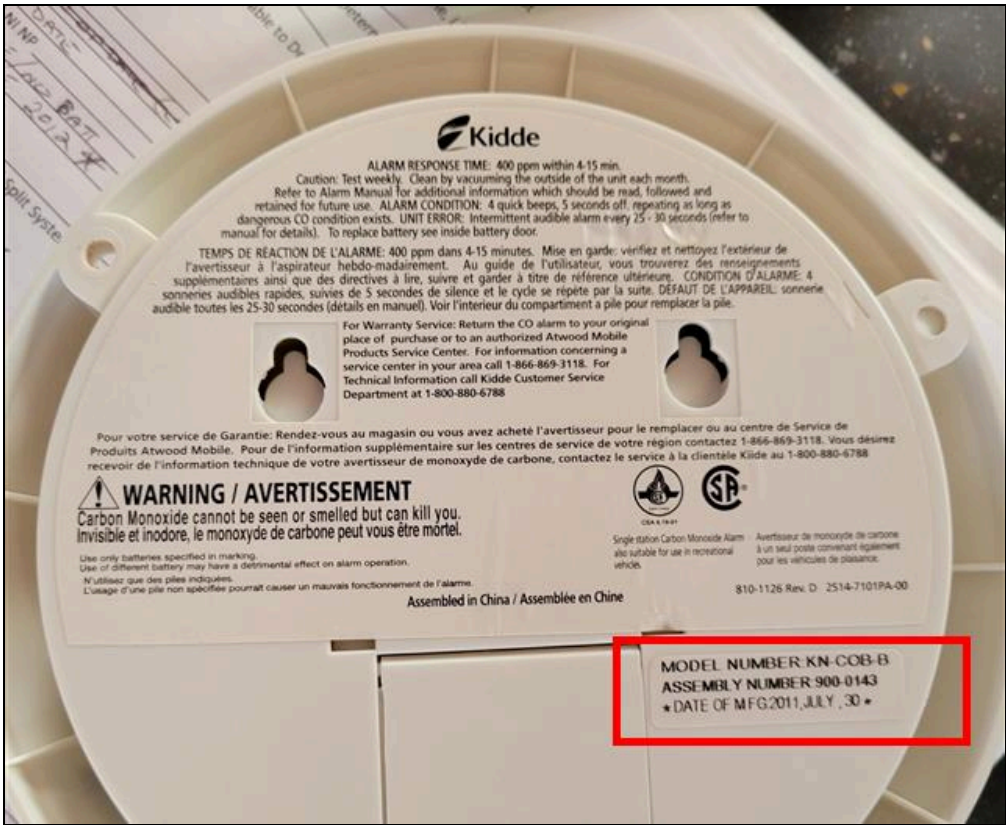
The inspector noted that the CO detector in the bedroom on the wall near the hall entry door has an expiration date greater than the 7 years recommended replacement per NFPA 1192-31 for manufacturers requirements as well as not having any batteries installed. It is recommended this be repaired by a qualified RV Technician before the vehicle is occupied.

**13.3** The inspector noted that the CO detector in the bedroom on the wall near the hall entry door has an expiration date greater than the 7 years recommended replacement per NFPA 1192-31 for manufacturers requirements as well as not having any batteries installed. It is recommended this be repaired by a qualified RV Technician before the vehicle is occupied.

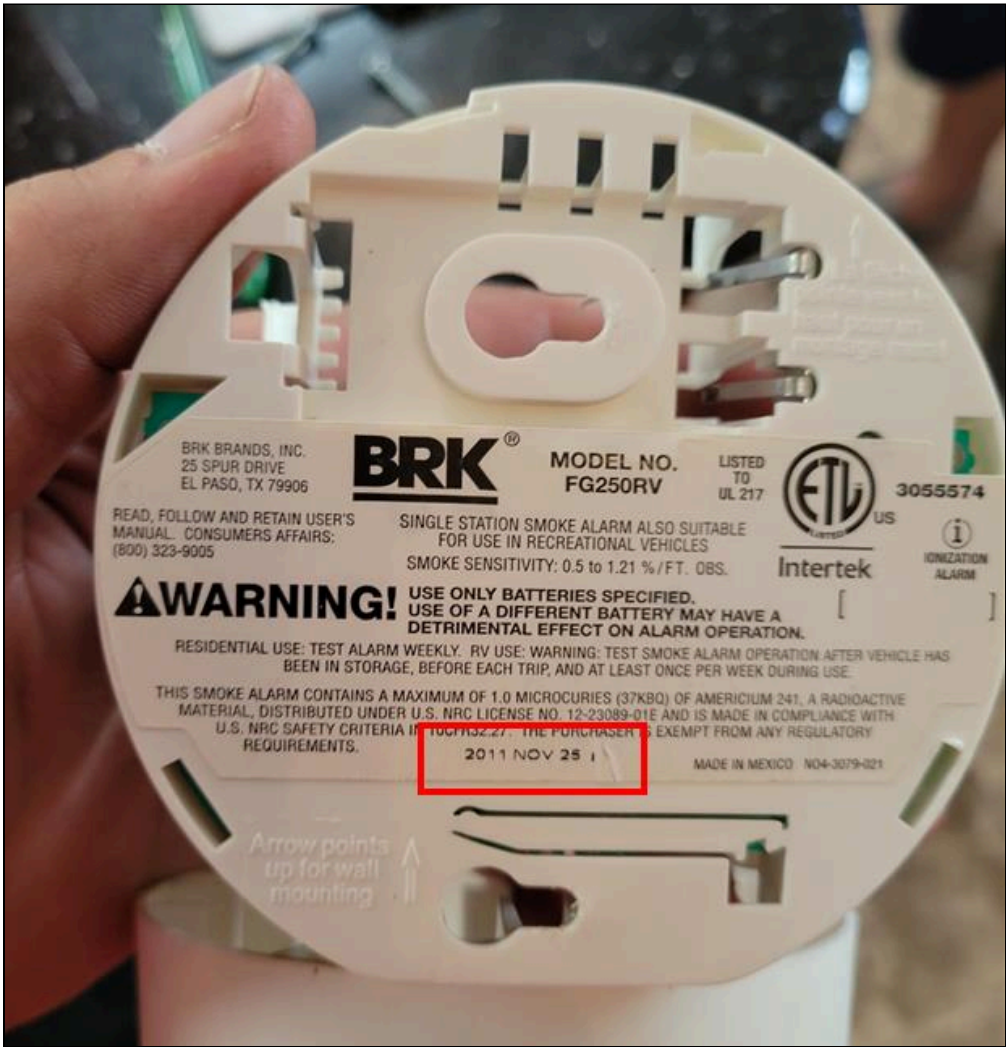
smoke detector manufacture date

The inspector noted that the smoke detector on the hall area ceiling, near the bathroom door, has an expiration date greater than the 60 month recommended replacement per NFPA 1192-31 for manufacturers requirements. It is recommended this be repaired by a qualified RV Technician before the vehicle is occupied.

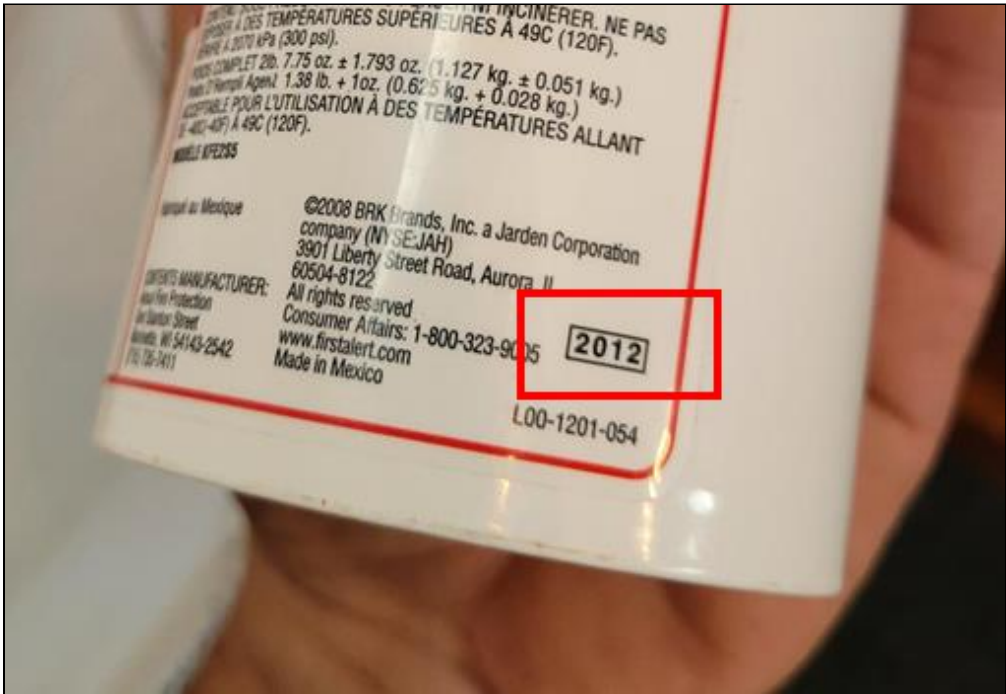
Fire extinguisher manufacture date

The inspector noted that the fire extinguisher by the door has an expiration date greater than the 60 month recommended replacement per NFPA 1192-31 for manufacturers requirements. It is recommended this be repaired by a qualified RV Technician before the vehicle is occupied.
