# RV Inspection Report

**Inspection Date:** 1/19/2022

2012 Keystone Cougar 330RBK

**Suite Wheels RV Inspections and Services, LLC.**

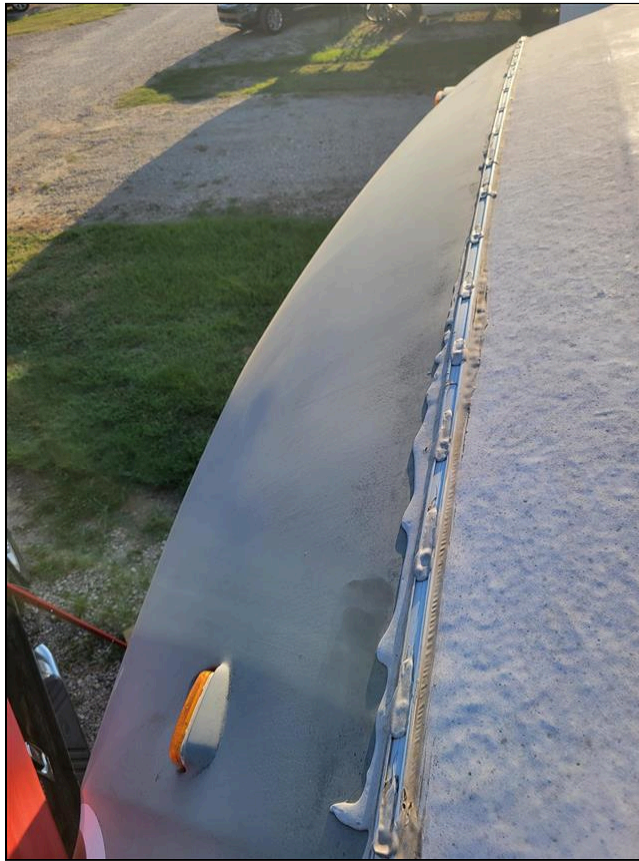
front cap joint seam - street side to curbside

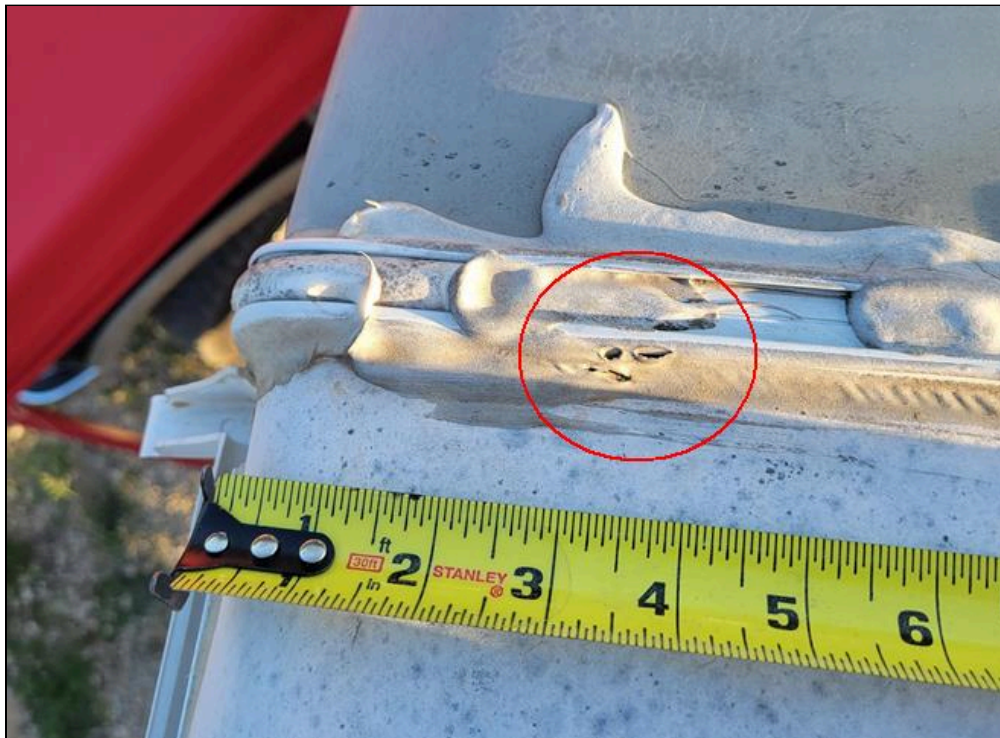
(2) The Inspector noted three potential water intrusion points on the streetside front cap near the gutter downspout. Two directly at the downspout and the third is approximately 3.5 inches from the streetside edge. It is recommended this be repaired by a qualified RV Technician.
- \$

front cap - 3 inches from street side

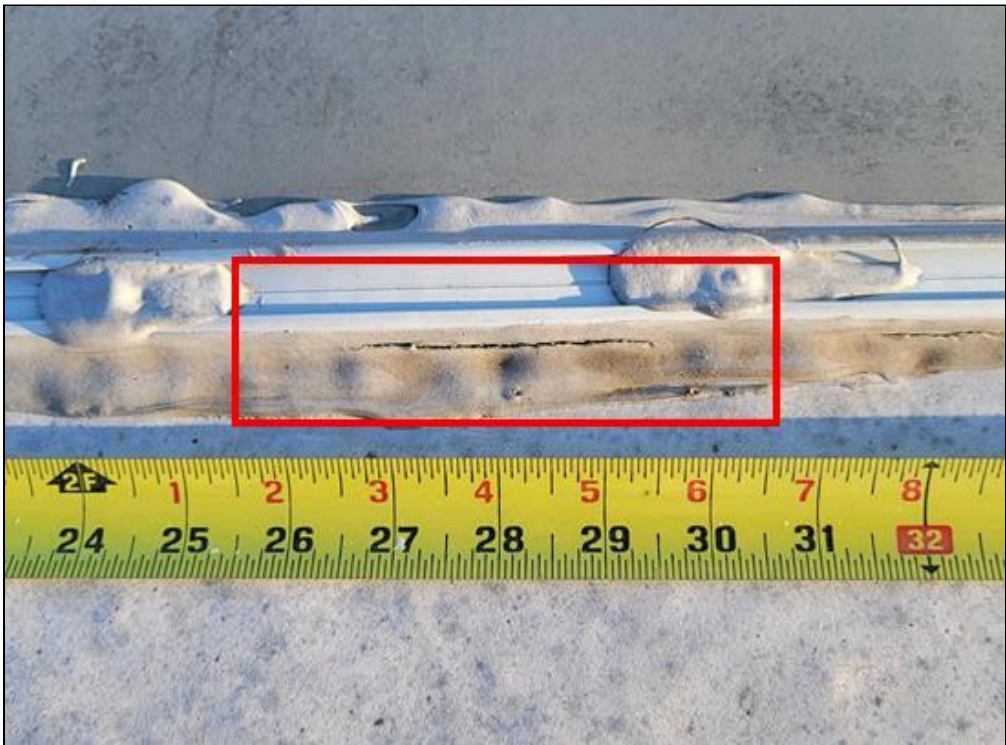
(3) The inspector noted potential water intrusion points along the front cap main seam from the streetside at 14. inches in the center and at 18 inches on the front edge, An approximately 3 inch crack in the sealant was noted from the streetside edge stretching from 26.5 inches to 29.5 inches.It is recommended this be repaired by a qualified RV Technician.
- \$

front cap - main seam

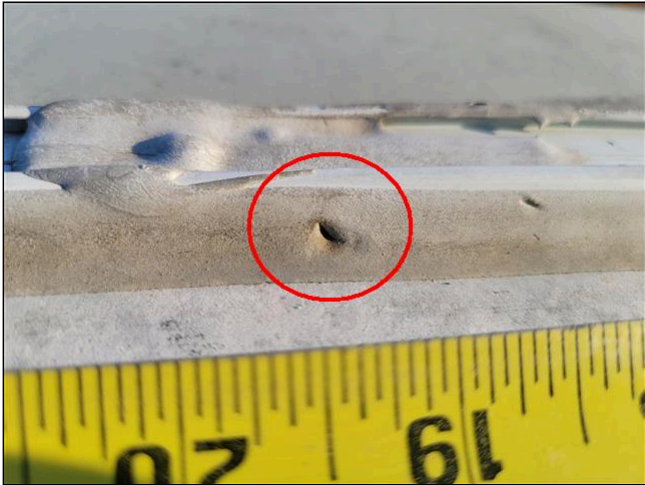
front cap - main seam

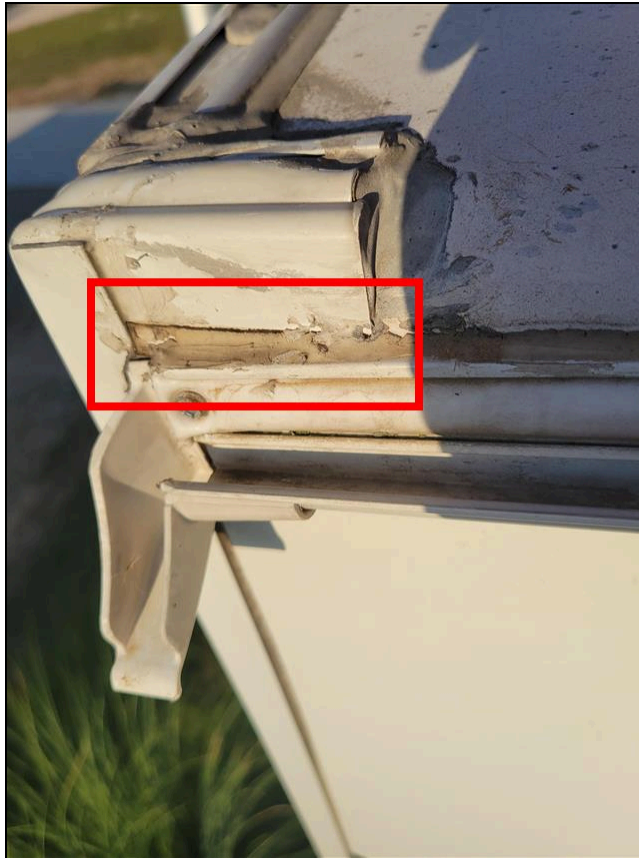
(1) The Inspector noted a potential water intrusion point on the curbside trim rail approximately two inches to the rear of the front gutter downspout. It is also noted there is a crack in the sealant in the curbside trim rail above the rear gutter downspout at the rear cap. It is recommended this be repaired by a qualified RV Technician.

curbside trim rail - end cap

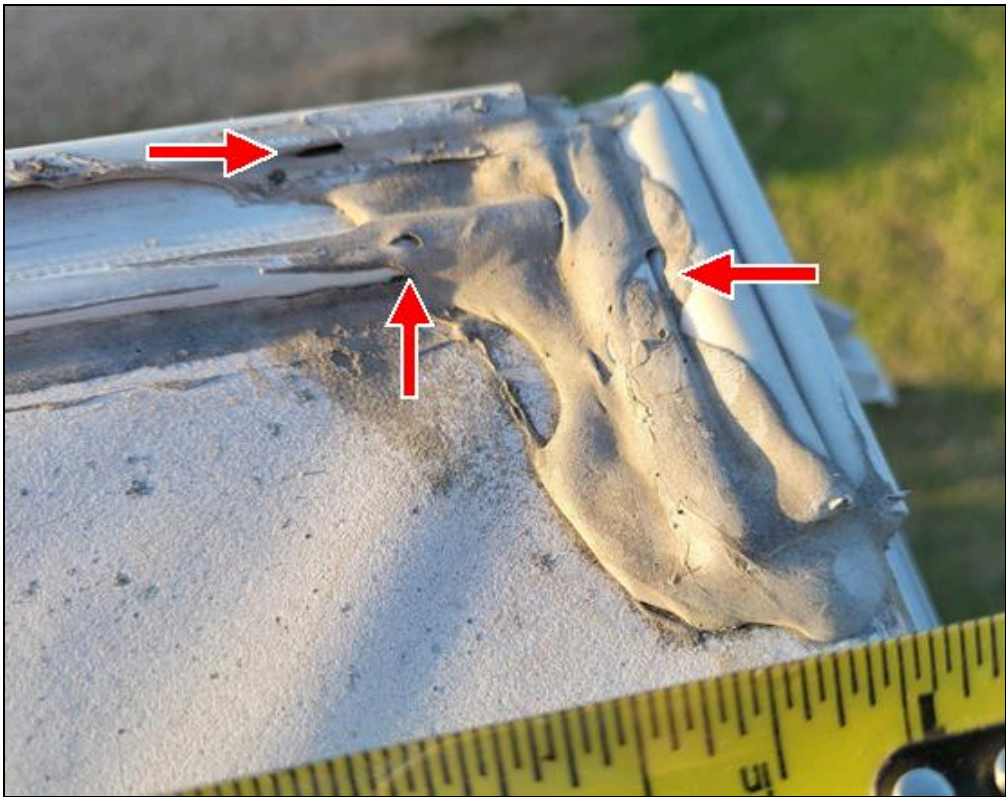
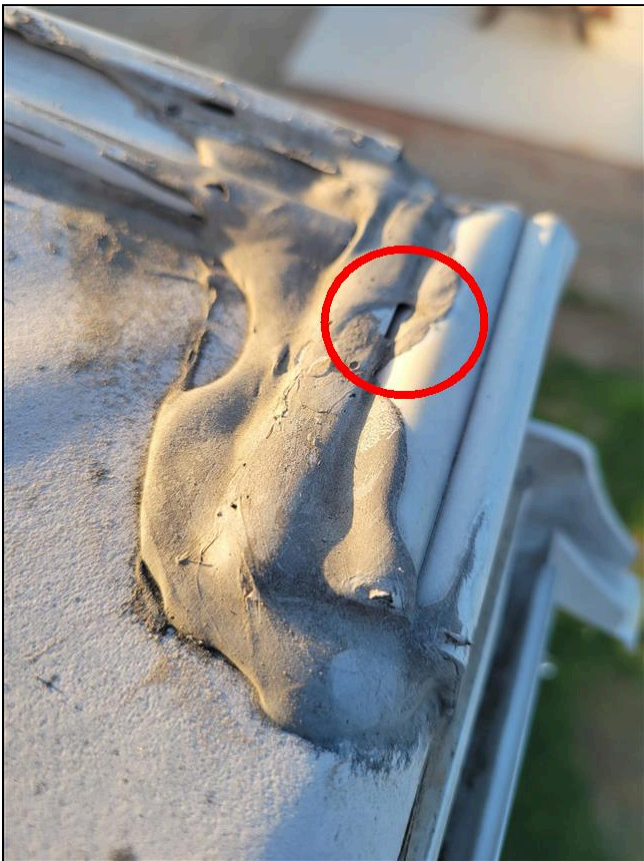
2.3 (2) The inspector noted a three potential water intrusion points on the rear cap at the streetside rear cap corner as well as on the rear cap at 18.5 inches and 30.5 inches from the streetside edge. It is recommended this be repaired by a qualified RV Technician.

rear cap joint seal - streetside corner

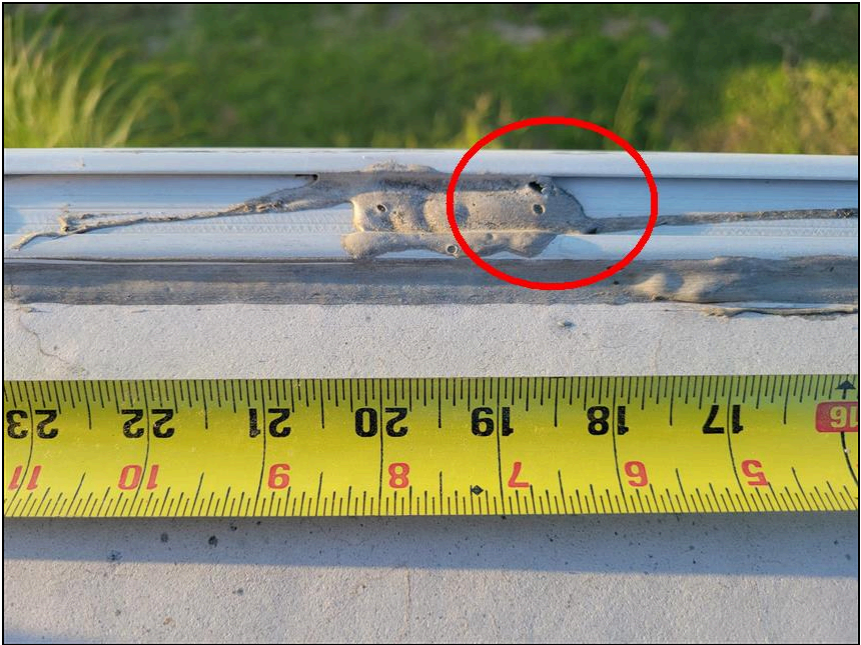
**2.4 (1)** The inspector noted multiple potential water intrusion points on the streetside trim rail where the rail meets the rear cap gutter downspout. It is recommended this be repaired by a qualified RV Technician.

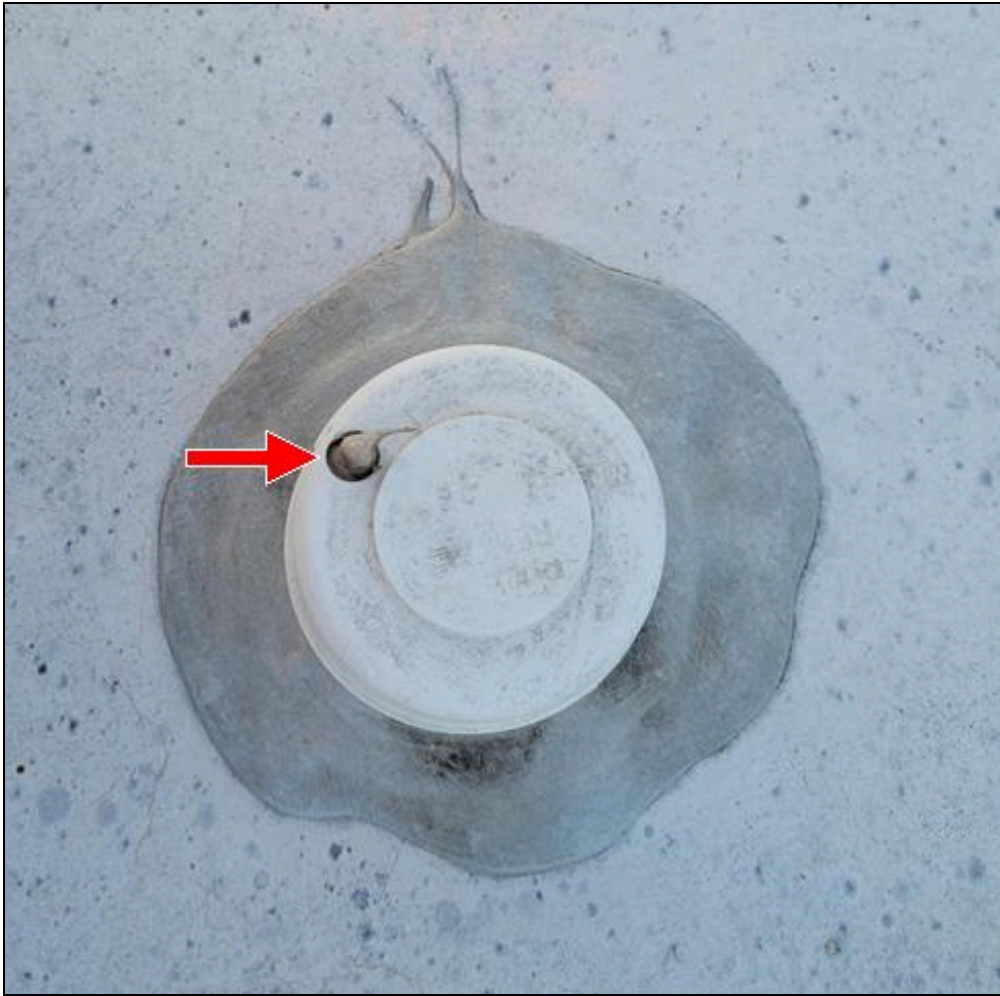
plumbing vent cap - middle

2.7 (2) The inspector noted that the plumbing vent cap is not fully seated onto it's base as well as two potential water intrusion points on the streetside edge of the sealant of the front most plumbing vent cap. It is recommended this be repaired by a qualified RV Technician.

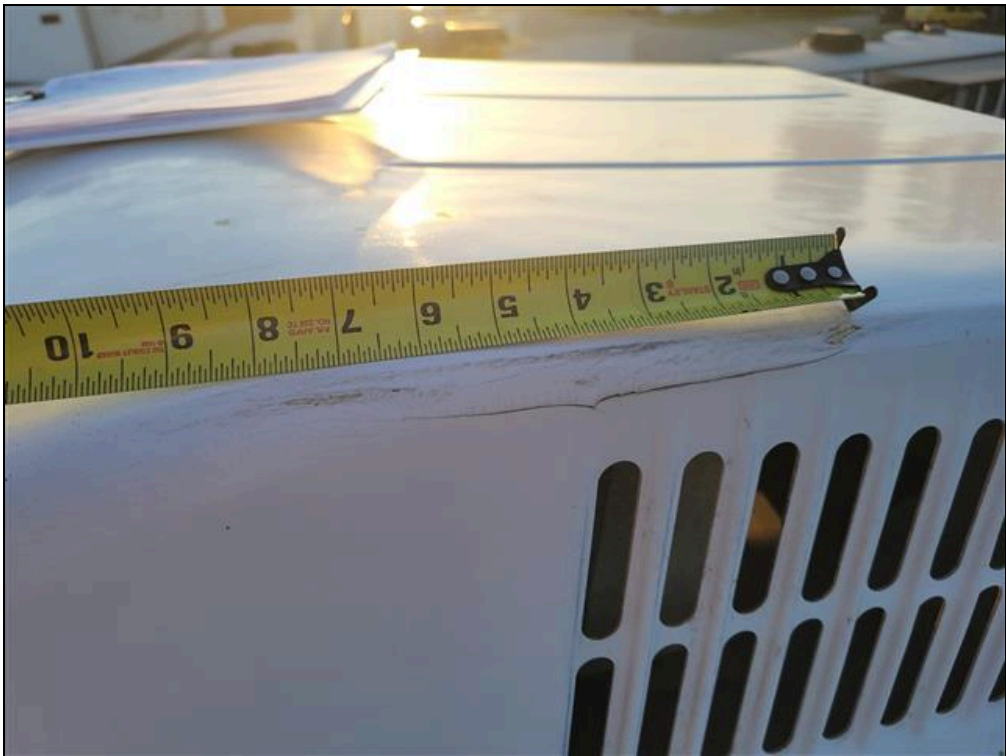
The inspector noted multiple cracks in the shroud of the air conditioning unit. The unit has a 6 inch crack in the center on the front edge, a 6 in crack on the top edge of the streetside, a 3 inch crack on the streetside lower rear corner, and a 3 inch crack on the curbside rear corner. This is a life safety issue due to the risk of the shroud coming loose/off during transport and causing a hazard on the road. It is recommended this be repaired by a qualified RV Technician.

ac shroud - streetside top

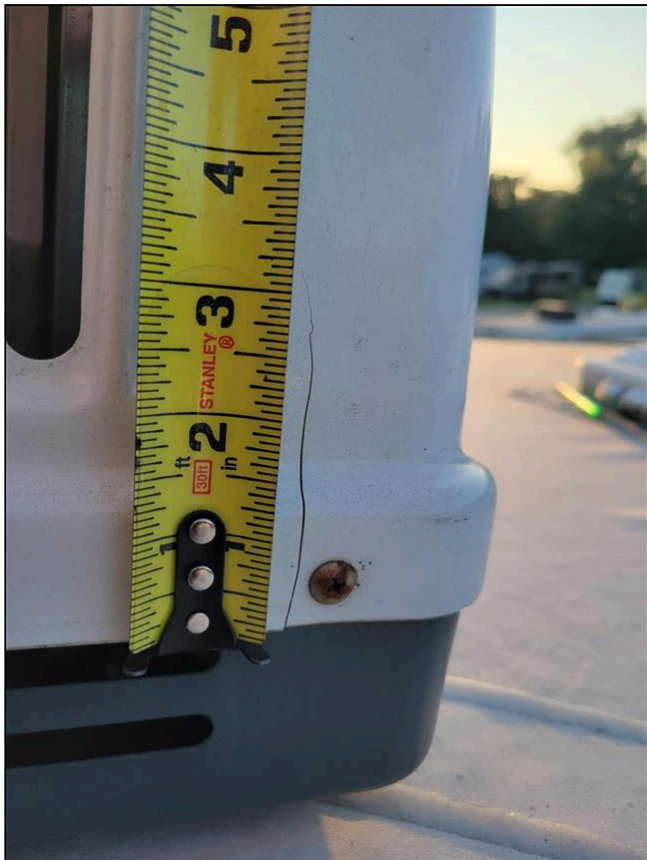
ac shroud - streetside corner

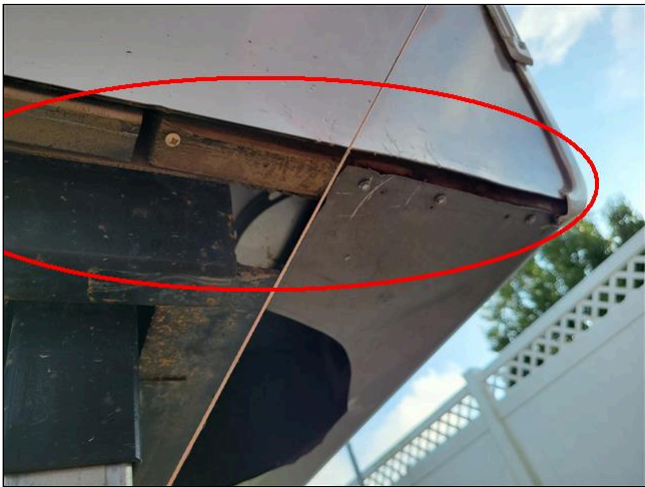
(1) The inspector noted a crack in the fiberglass on the curbside lower corner as well as potential water intrusion point with loosened joint seal and sealant on the same corner. It is recommended this be repaired by a qualified RV Technician.

front cap - lower streetside corner

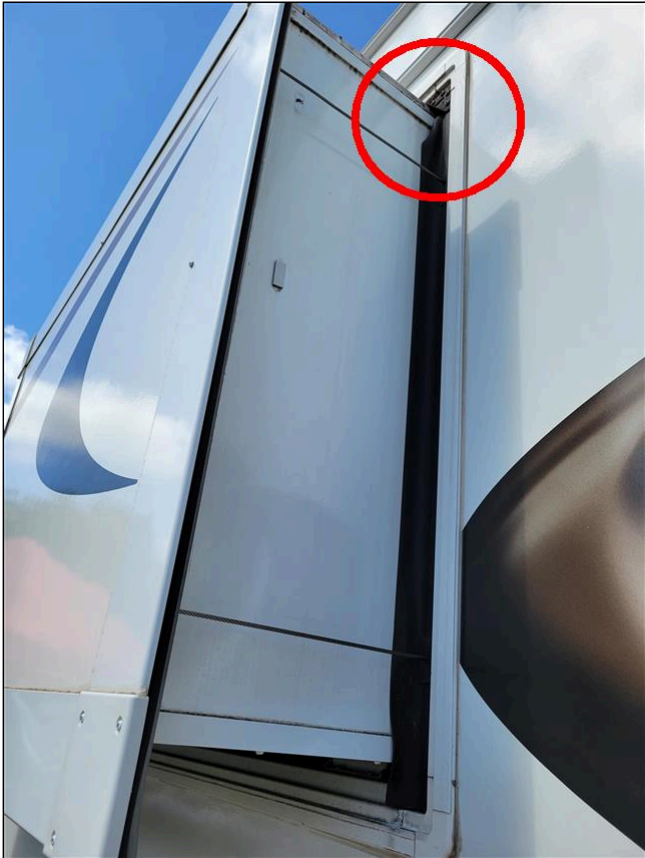
The inspector noted that the blade seal on the front edge of the of the front slideout is not fully deployed in the lower corner as well as the upper corner of the rear edge of the front slideout, suggesting the slide out is out of alignment. It is recommended this be repaired by a qualified RV Technician.

front slideout - rear blade seal

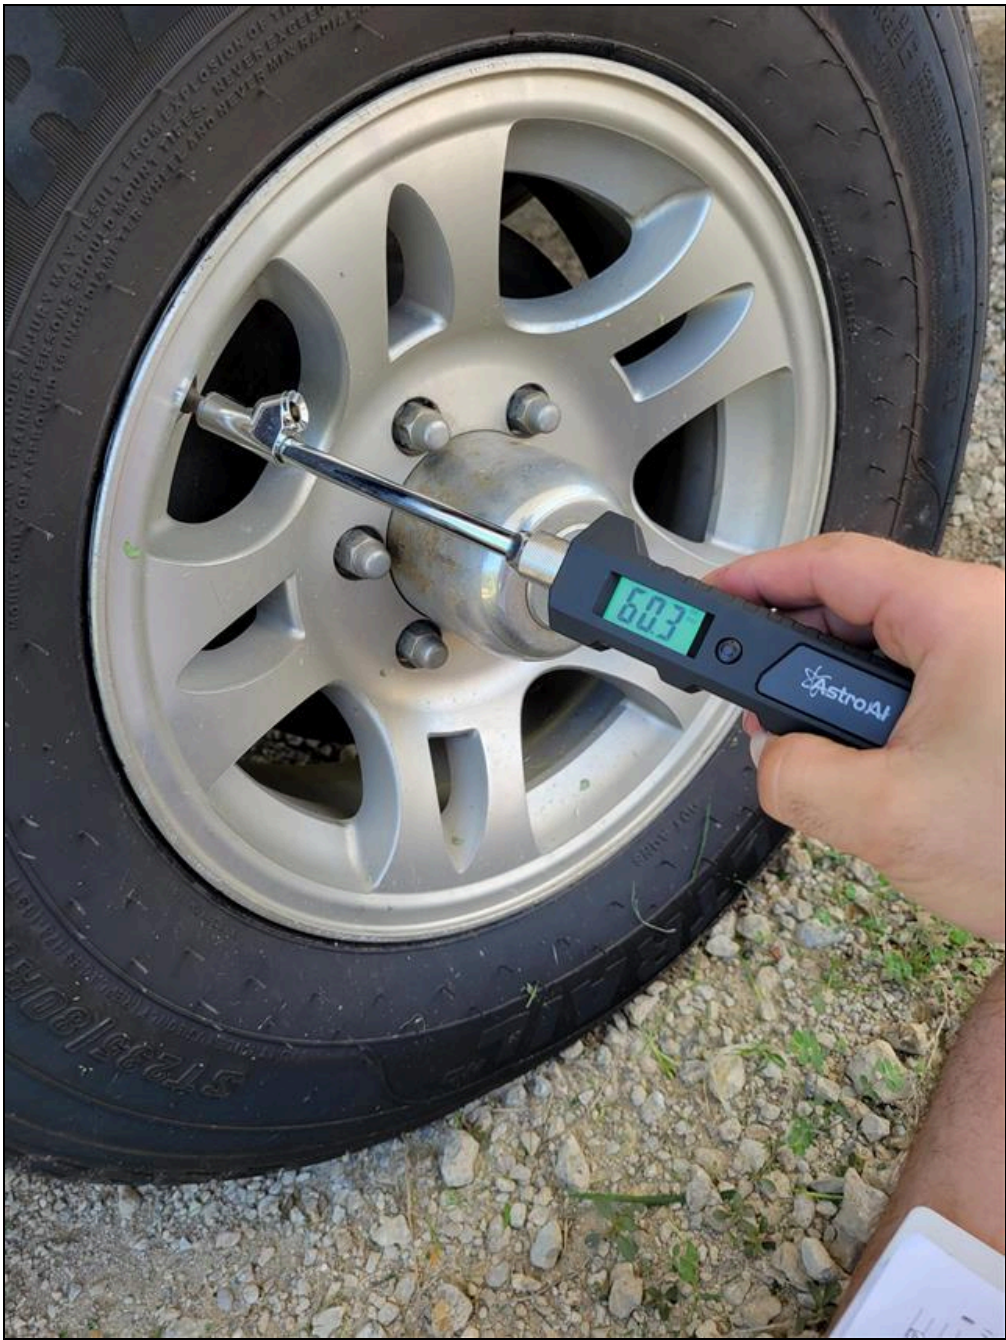
**+** **7.0.A** The inspector noted new tires were installed but the current air pressure in the tires is significantly low. This can result in a blow out of the tire while operating the vehicle. It is recommended this be fixed by a qualified tire expert before use of the vehicle.

tire presuure - curbside front

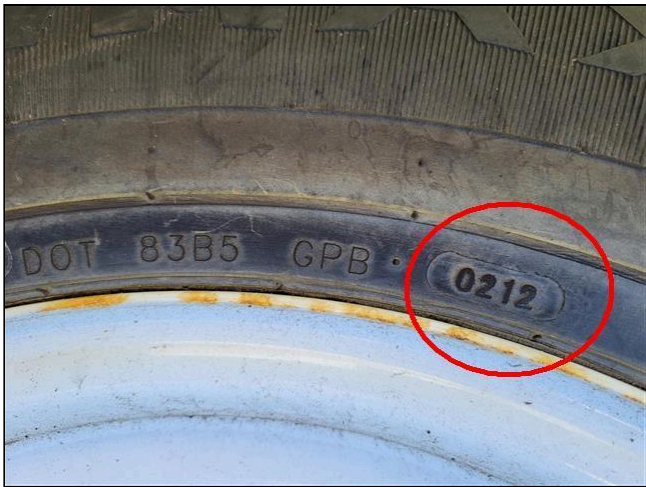
spare tire - DOT date

The inspector noted the spare tire installed on the rear bumper was past the 5 year date renewal by the DOT and the current air pressure in the tires is significantly low. This can result in a blow out of the tire while operating the vehicle. It is recommended this be fixed by a qualified tire expert before use of the vehicle.

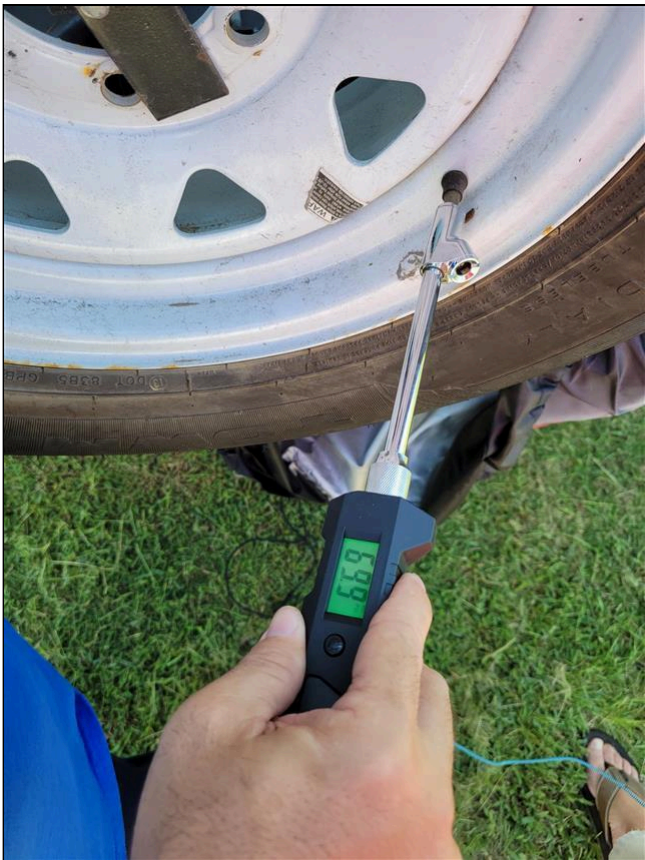
spare tire - air pressure

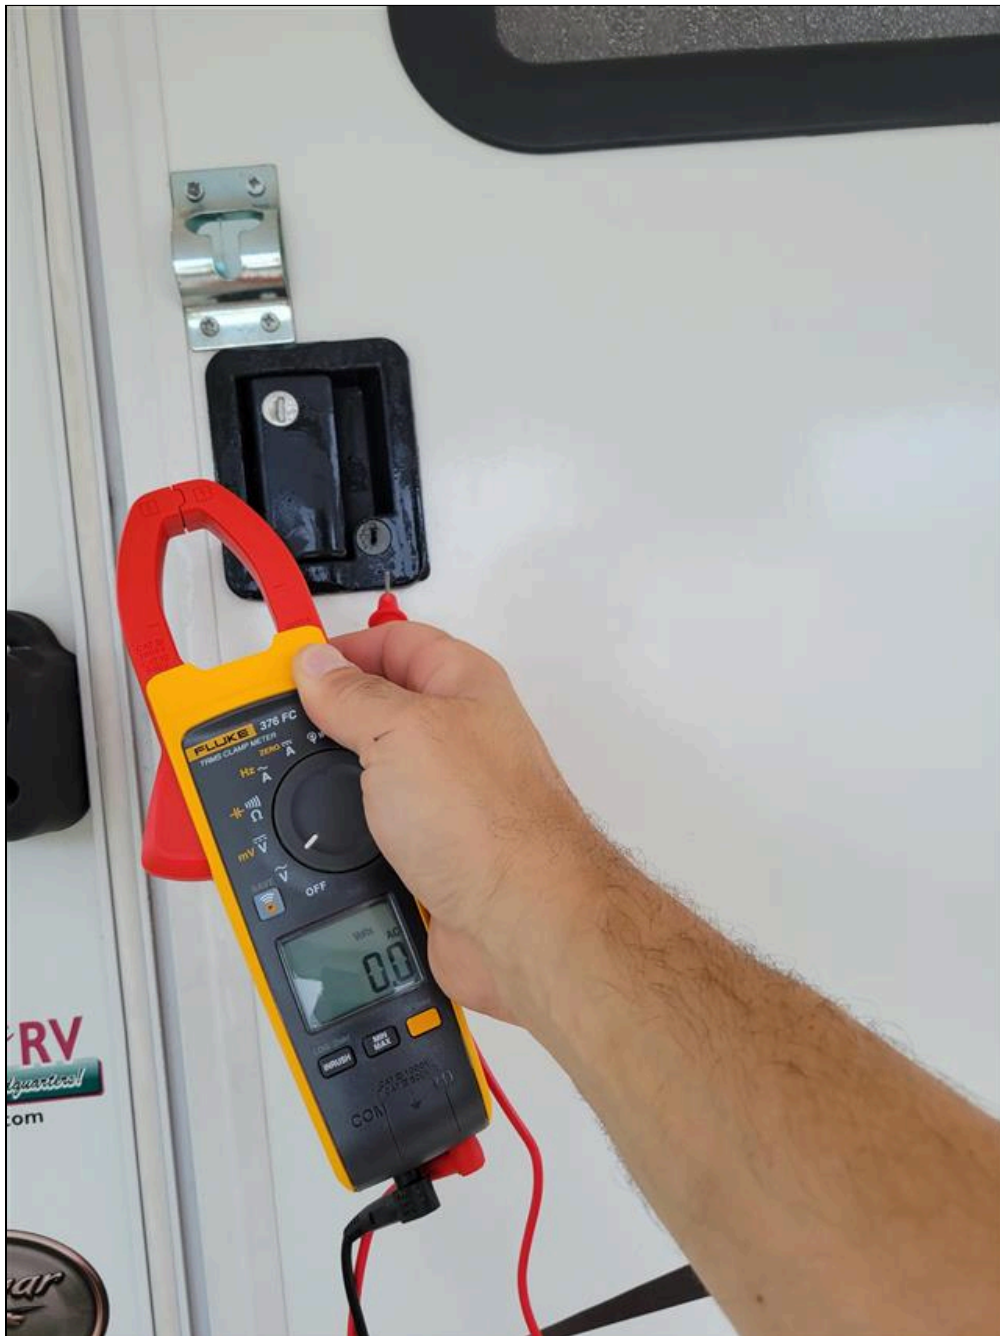
🔍 11.2 door handle: hot skin test

door handle - hot skin test

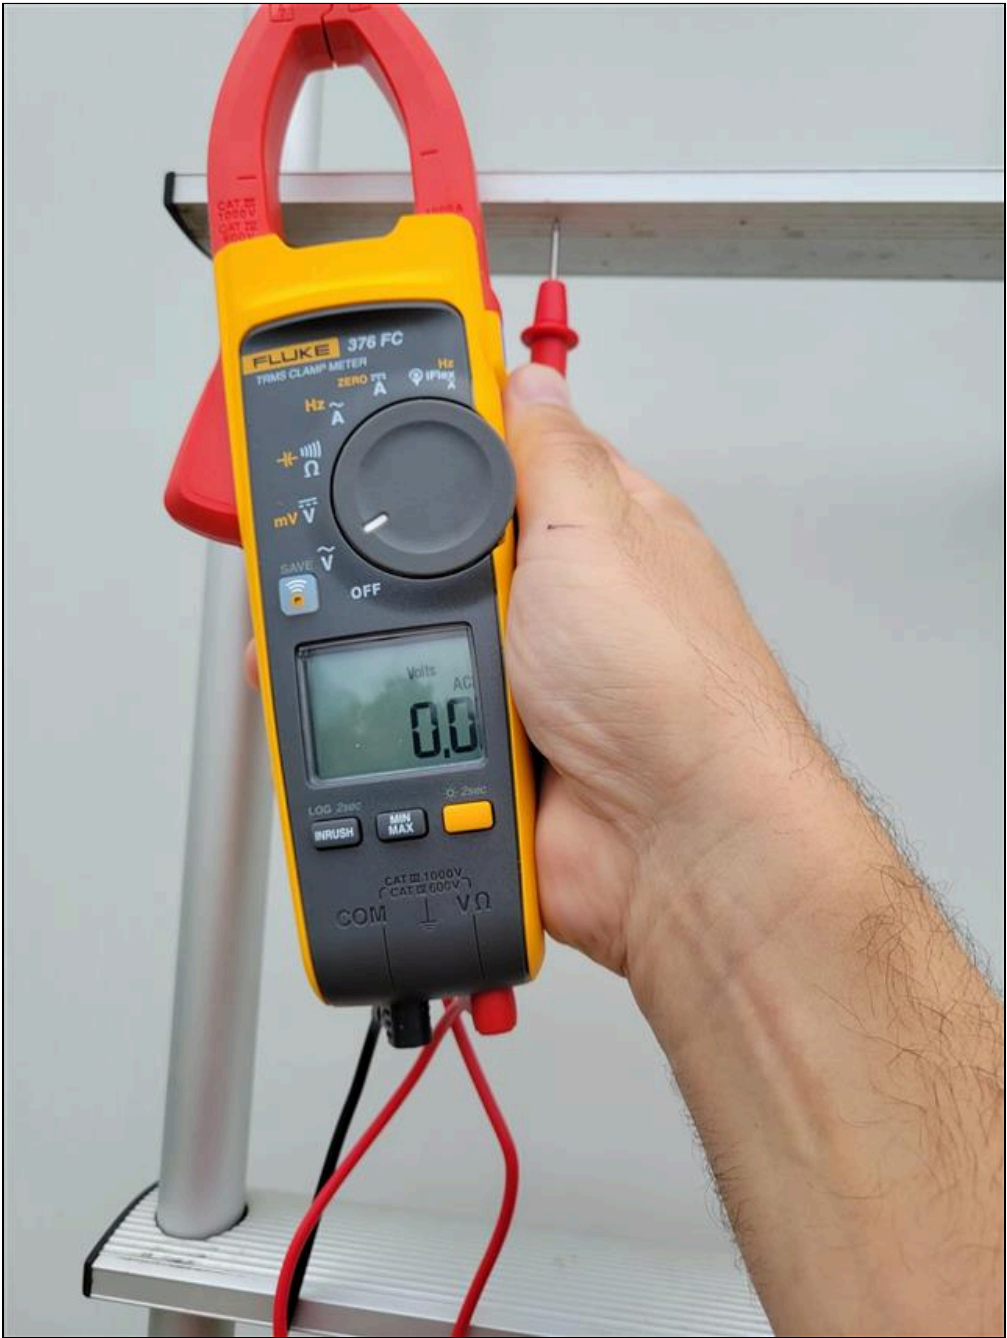
11.4 Ladder: hot skin test

ladder - hot skin test

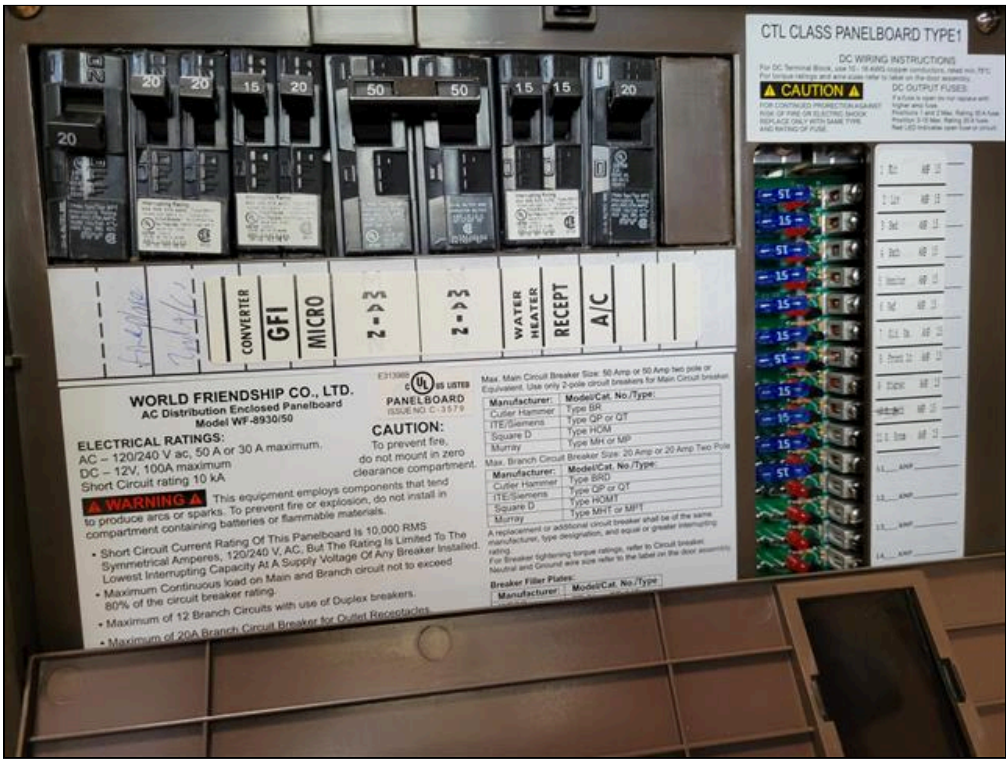
11.11 Electrical and fuse panel

power panel

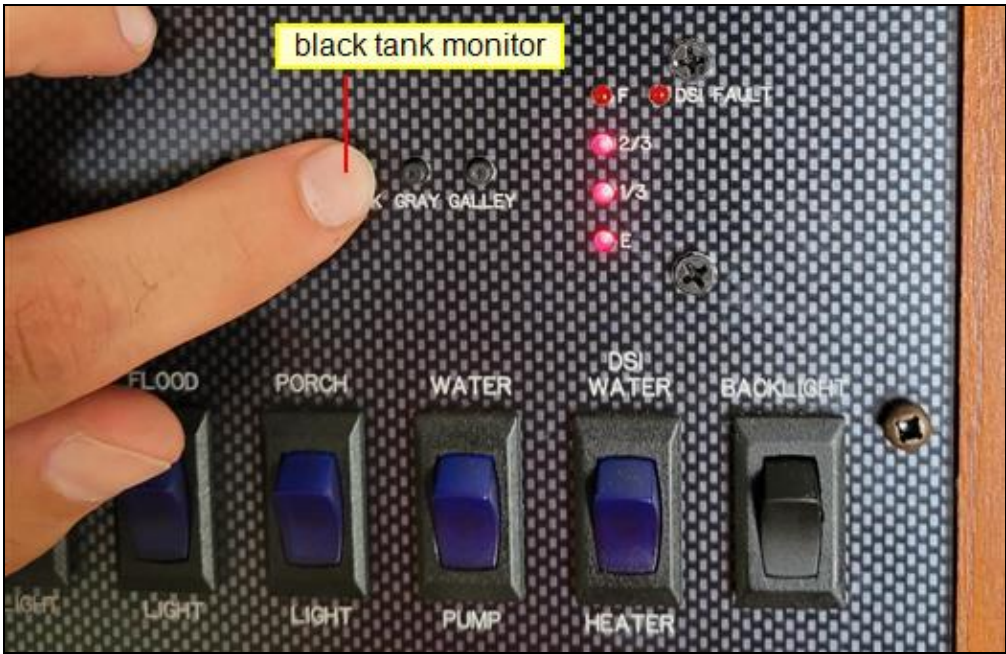
black tank monitor

**12.8** The inspector noted that the black and galley water level monitor system did not go to zero after the system was emptied. The black tank monitored at 3/4 full remaining and the galley tank monitored at 1/2 full remaining. The inspector noted that the fresh water system was not fully drained during the testing. It is recommended this be repaired by a qualified RV Technician.

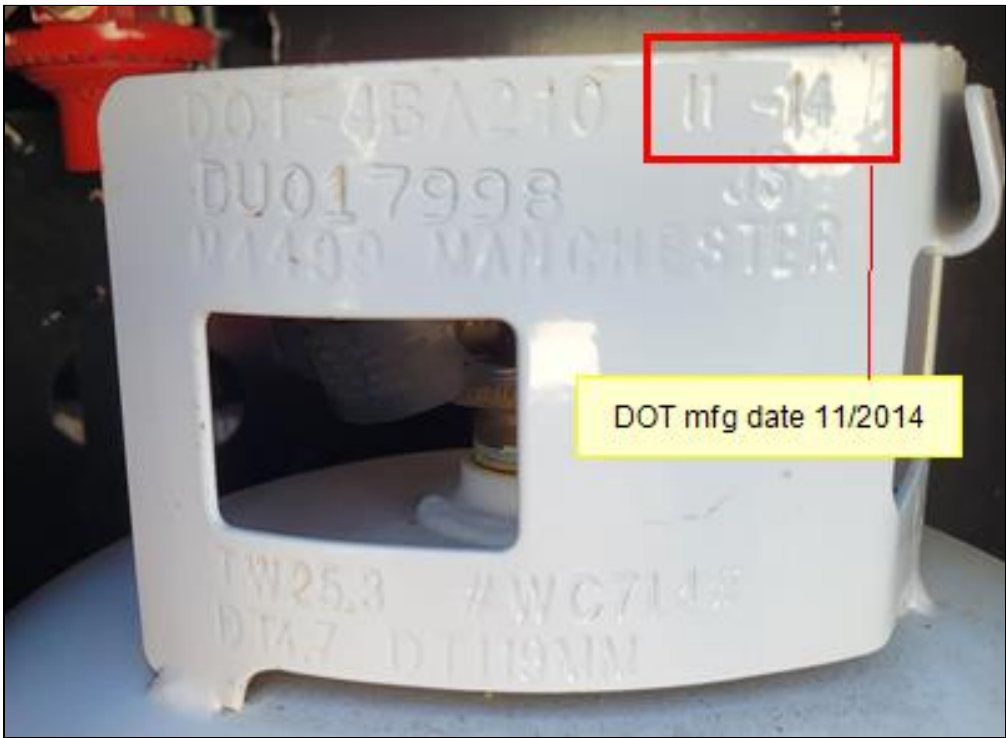
13.0 DOT tank manufacture date:

DOT manufacture date

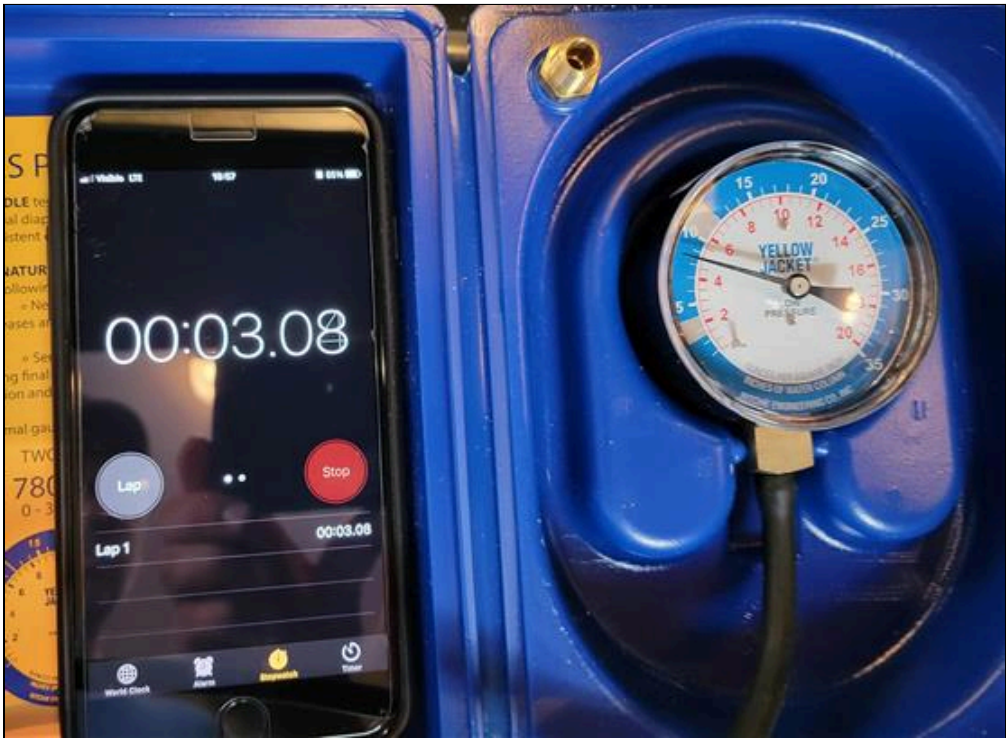
13.1 LP drop test

LP drop test - start

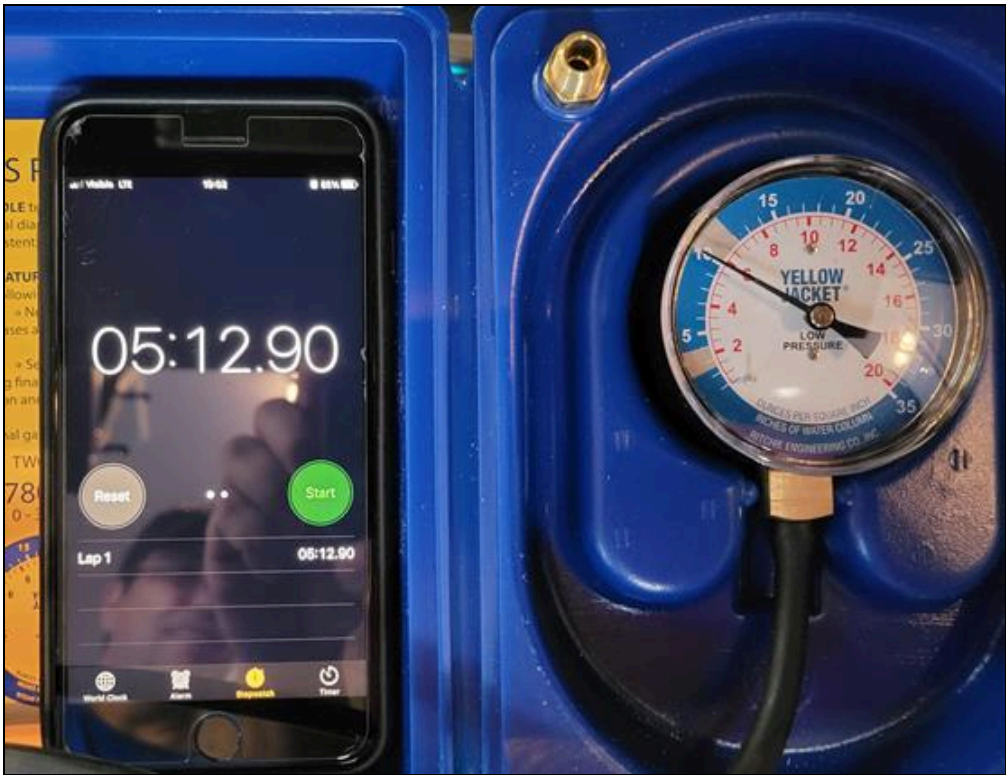
LP drop test - end

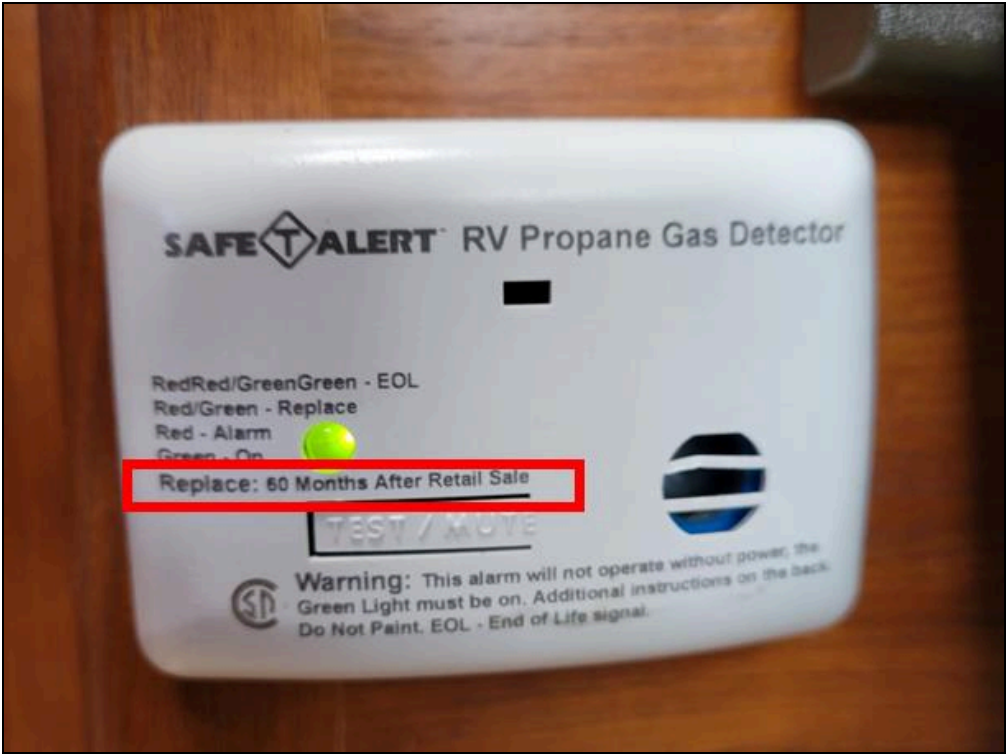
propane detector

**13.2** The inspector noted that the LP detector in the galley area near the power panel has an expiration date greater than the 60 month recommended replacement per NFPA 1192-31 for manufacturers requirements. It is recommended this be repaired by a qualified RV Technician before the vehicle is occupied.

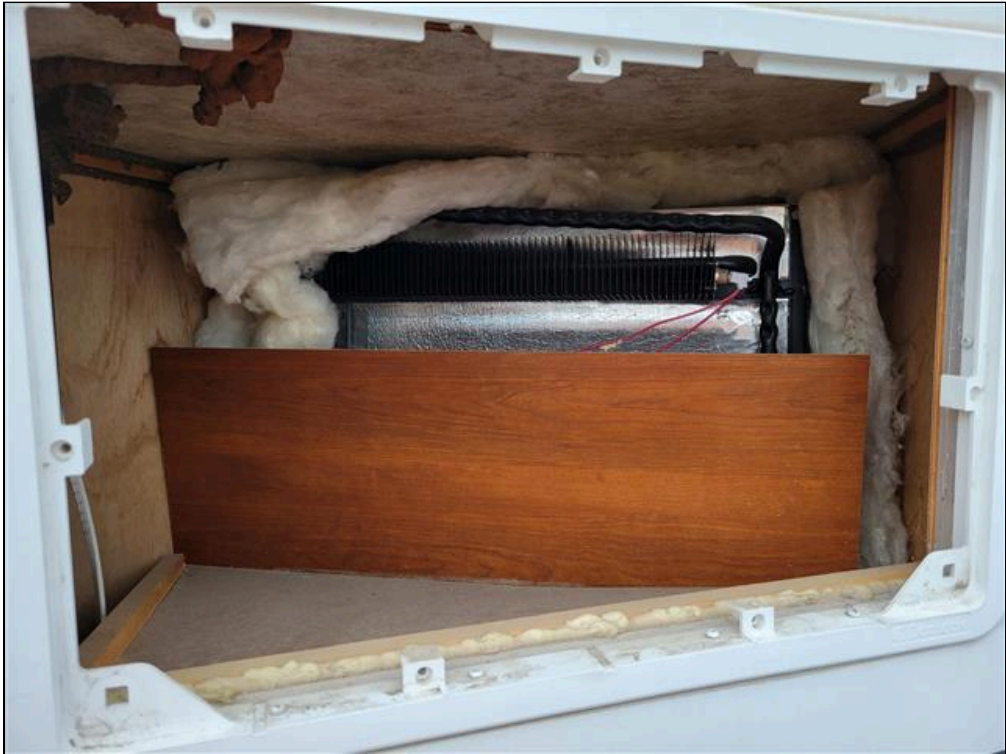
Refrigerator - backside venting

14.10 The inspector noted improper baffling and insulation on the backside of the refrigerator that will affect proper cooling cycle and performance of the refrigerator. It is recommended this be repaired by a qualified RV Technician.

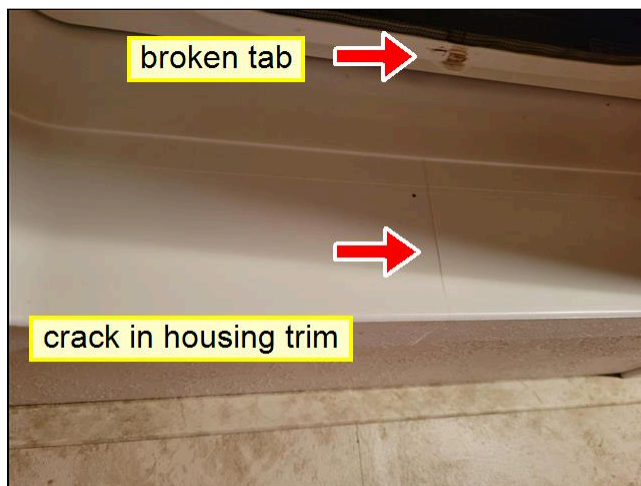
Bathroom ceiling vent

**17.6** The inspector noted several broken "lock-in" tabs for the screens of all four of the ceiling vents. The inspector also noted a vertical crack in the housing trim of the bathroom vent. It is recommended this be repaired by a qualified RV Technician.

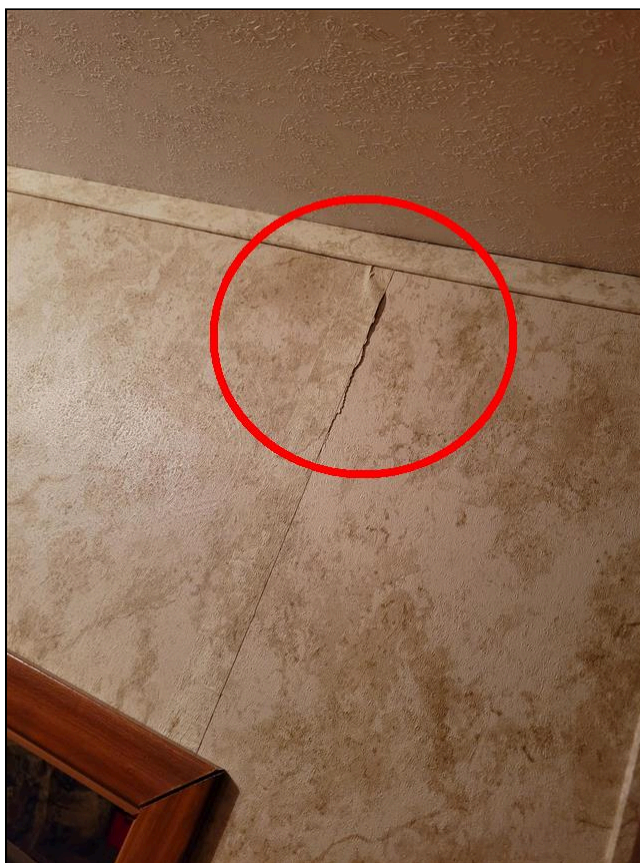
Wall coating - bunkhouse

**17.21** The inspector noted that the seam of wall panel coating is coming loose above the door on the inside of the bunkhouse. It is recommended this be repaired by a qualified RV Technician.

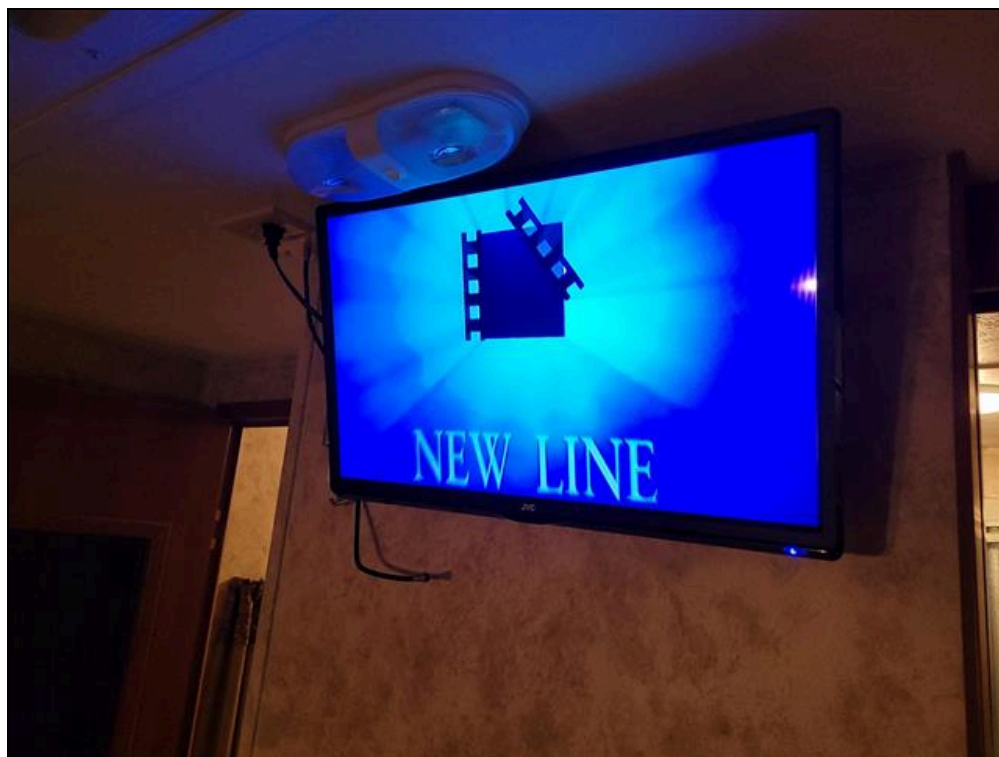
🔍 **19.0.A** Bedroom TV: DVD on

bedroom TV - DVD on
